**Parks and Recreation Commission
Regular Meeting
April 8, 2026, 8:00 AM
Meets virtually via Microsoft Teams**

TOWN OF LA PLATA
Parks and Recreation Commission Minutes
January 14, 2026, 8:00 AM
Regular Meeting
Meets virtually via Microsoft Teams

Park	Address / Location	Year Built	Owner	Foundation Condition	Equipment Condition	Measurements / Square Footage (internal area)	Equipment Manufacturer	Signage	Notes
Wills Park	503 St Mary's Ave	1984	Town	Poor	Poor / Safety Issues	97 x 77 = 7,469		hrs and restrictions	Full playground upgrade FY2026. Walkway - 205 linear sq feet, future improvement need
Clarks Run	End of Silver Linden Dr	1983	Town	Fair	Good	77 x 70 = 5,390	It's a Miracle	hrs, restrictions, safety	Suggest PIP and equipment upgrade - 2029
Agricopia	Across from 1037 Crop Pl	2000	Town	Good	Very Good	72 x 48 = 3,456	Eagle	hrs, restrictions, safety	Suggest PIP and equipment upgrade - 2030; or when needed
Caroline Dr (2) - Tot Lot	End of Caroline Dr	1990	Town	Poor	Poor	54 x 30 = 1,620		hrs and restrictions	Suggest we remove and not replace. Playground now adjacent to La Plata Pkwy. If Town invests, we should only invest in large Caroline Dr park.

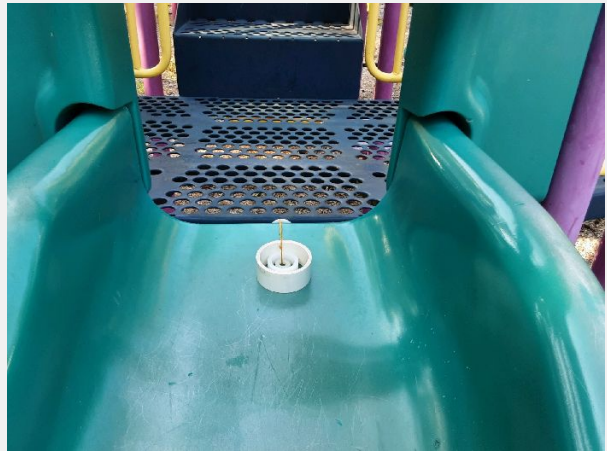
Is equipment free of openings that can cause entrapments?	Yes	●
Do slides < 48" high have max. 11" height at exit; slides > 48" have exit height between 7-15"; and all slide exits are rounded or curved	No	▲
<ul style="list-style-type: none"> • Right turn slide exit should be no higher than 11" - currently 21" high. • Straight slide should be no higher than 15" - currently 17" high.

* Adding appropriate depth of surfacing would help.

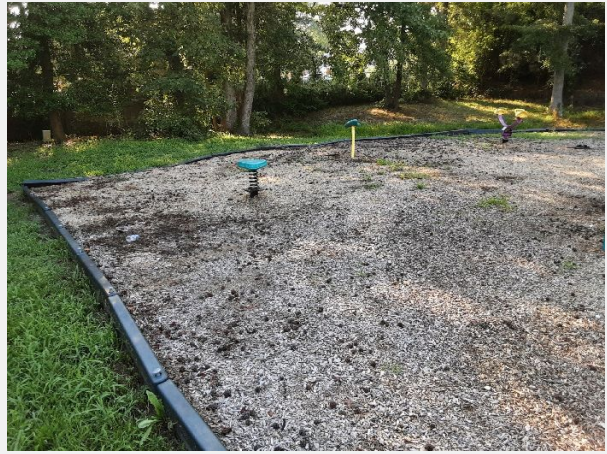
- Measured throughout today to find anywhere from 0" - 5" of surfacing and there's a lot of undulations on site.
- There's weeds & grass, lots of prickly gumballs - the site needs cleaning out, leveling and filling up.

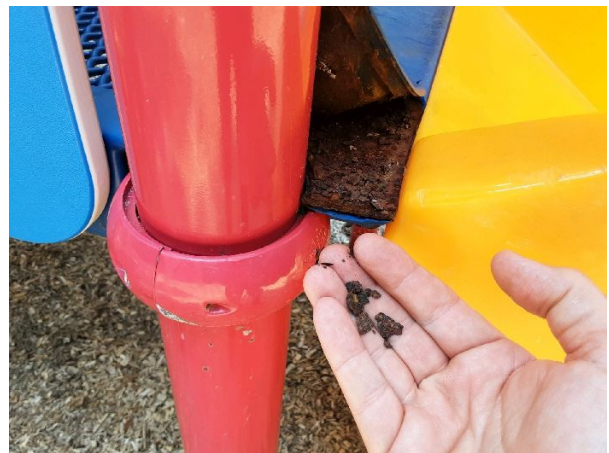
• Structure #1: PVC coating on decking & stairs has peeled away exposing delaminated, decomposing rusted metal on both the stairs and the decks.
Has the fault been repaired? No

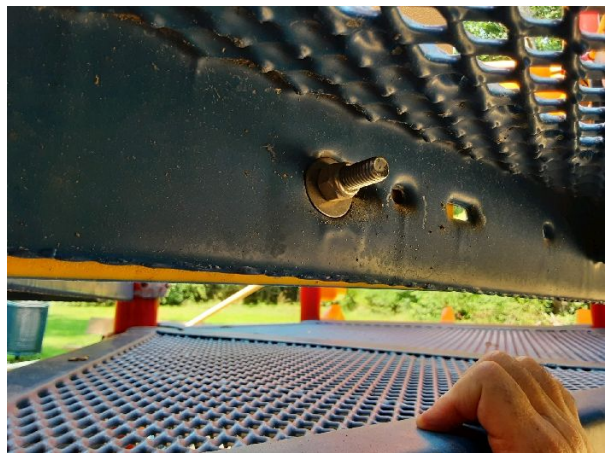
- Structure #1: Protrusions throughout where fasteners are not the original manufacturer provided parts creating protrusion / entanglement or impalement hazards. Has the fault been repaired? No

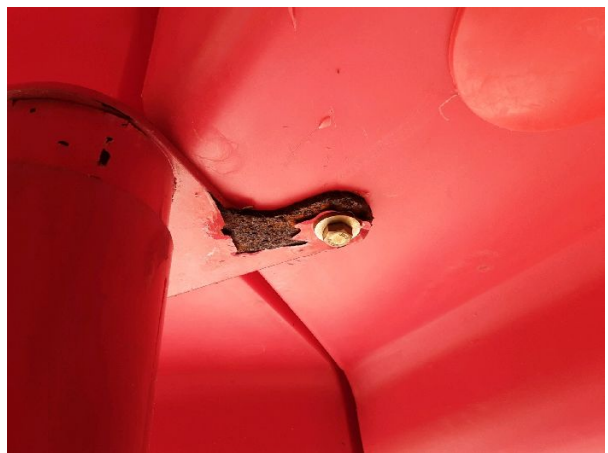
- Both Structures: Rust noted throughout where PVC has failed on the decking.
 - Structure #1: significant rust throughout the rest of the structure and / or chipped paint.
- Has the fault been repaired? No Priority: Low

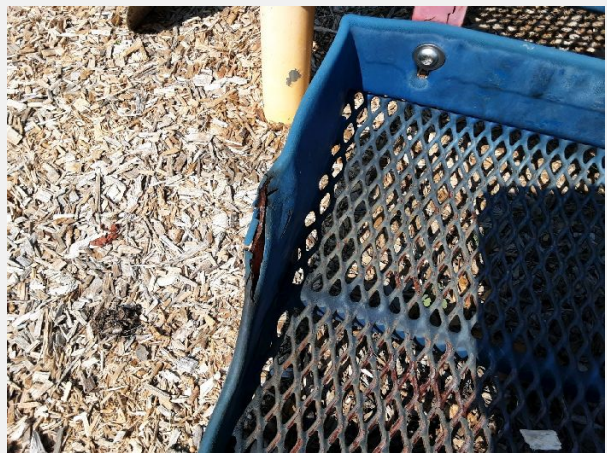
• Structure #2: The stairs on the transfer station is failing. The others are beginning to fail but the riser and the stairs on the transfer station are already happening. Has the fault been repaired? No

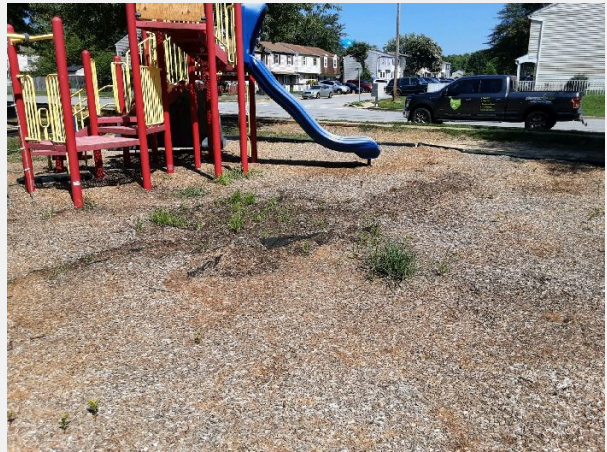
- Site #1: Measured throughout site and average depth is somewhere between 2" - 4".
- Site #2: Measured as much as 12" on the back side and as little as 2" in the front. In the middle there is 2" - 4" for the most part.
- There's significantly less than the required depth in & around the actual equipment, plus there's lots of grass and weeds and exposed fabric.
