**Parks and Recreation Commission
Regular Meeting
April 8, 2026, 8:00 AM
Meets virtually via Microsoft Teams**

TOWN OF LA PLATA
Parks and Recreation Commission Minutes
January 14, 2026, 8:00 AM
Regular Meeting
Meets virtually via Microsoft Teams

Park	Address / Location	Year Built	Owner	Foundation Condition	Equipment Condition	Measurements / Square Footage (internal area)	Equipment Manufacturer	Signage	Notes
Wills Park	503 St Mary's Ave	1984	Town	Poor	Poor / Safety Issues	97 x 77 = 7,469		hrs and restrictions	Full playground upgrade FY2026. Walkway - 205 linear sq feet, future improvement need
Clarks Run	End of Silver Linden Dr	1983	Town	Fair	Good	77 x 70 = 5,390	It's a Miracle	hrs, restrictions, safety	Suggest PIP and equipment upgrade - 2029
Agricopia	Across from 1037 Crop Pl	2000	Town	Good	Very Good	72 x 48 = 3,456	Eagle	hrs, restrictions, safety	Suggest PIP and equipment upgrade - 2030; or when needed
Caroline Dr (2) - Tot Lot	End of Caroline Dr	1990	Town	Poor	Poor	54 x 30 = 1,620		hrs and restrictions	Suggest we remove and not replace. Playground now adjacent to La Plata Pkwy. If Town invests, we should only invest in large Caroline Dr park.

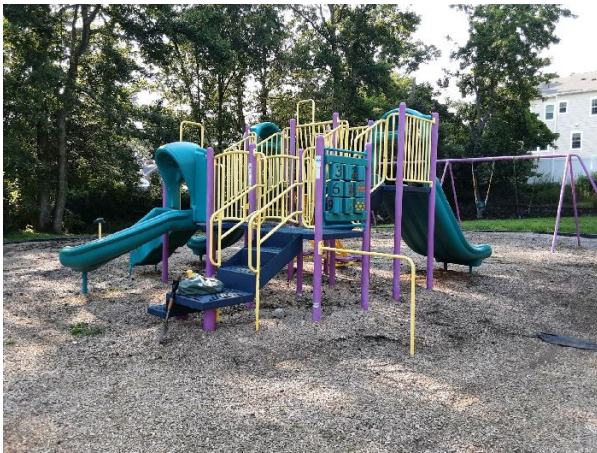
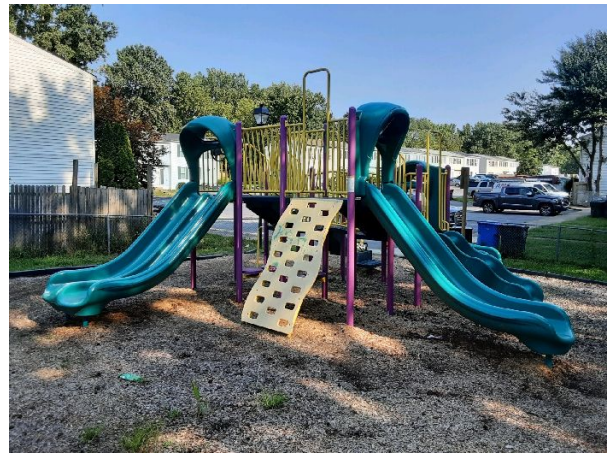
Are warning labels and age appropriate signage present and legible?	Yes	●
Does equipment have proper use zones?	Yes	●
Is equipment free of openings that can cause head entrapments?	Yes	●
Are support footings stable and buried below the protective surfacing materials?	Yes	●
Is the composite playset support structure in good repair, secure with no noted movement?	Yes	●
Are platforms and other related areas smooth with no damage, openings or sharp edges noted?	Yes	●
Are top portions including protective barriers, guard rails, support bars, grips, climbing equipment and other related devices fully	No	⚠

secured with no noted movement?

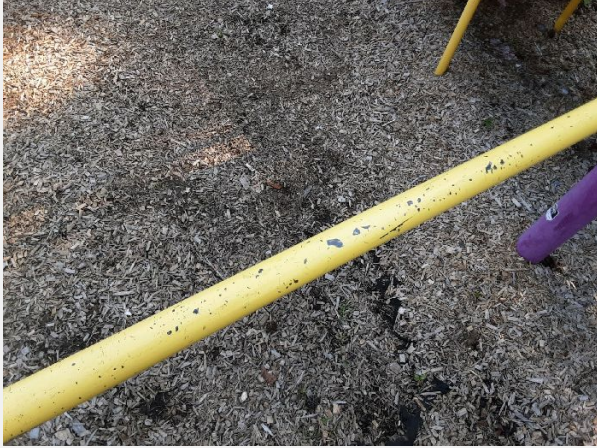
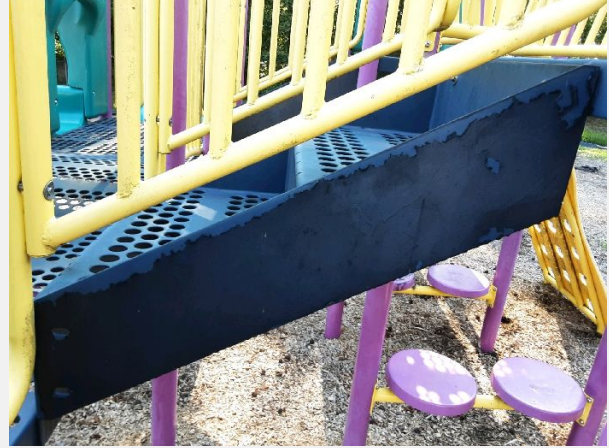
- Chipped paint & typical wear & tear.
- It appears that maybe the stairs & some of the decking was painted and is peeling.

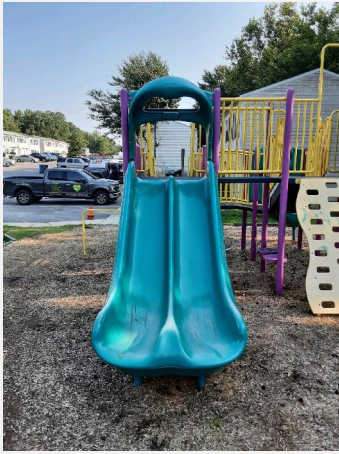
Does equipment have proper use zones?	Yes	●
Are support footings stable and buried below the protective surfacing materials?	Yes	●
Are top portions of slide including protective barriers, support bars and other related devices fully secured with no noted movement?	Yes	●
Is the slide support structure in good repair and secure with no noted movement?	Yes	●
Are access devices to slides (ladders, stairs, etc.) in good condition and secure with no movement noted?	NA	
Are all areas free of gaps between portions of slide including slide portions, platforms and other related areas?	No	▲
<ul style="list-style-type: none"> • There is a gap at the top of the right turn slide where it mounts to the deck. Slide entanglement gap. 		
Has the fault been repaired?	No	
Priority: Medium

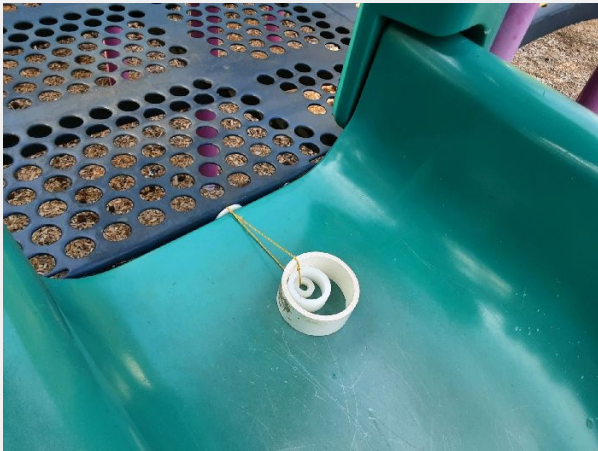
Is equipment free of openings that can cause entrapments?	Yes	●
Do slides < 48" high have max. 11" height at exit; slides > 48" have exit height between 7-15"; and all slide exits are rounded or curved	No	▲
<ul style="list-style-type: none"> • Right turn slide exit should be no higher than 11" - currently 21" high. • Straight slide should be no higher than 15" - currently 17" high.

* Adding appropriate depth of surfacing would help.

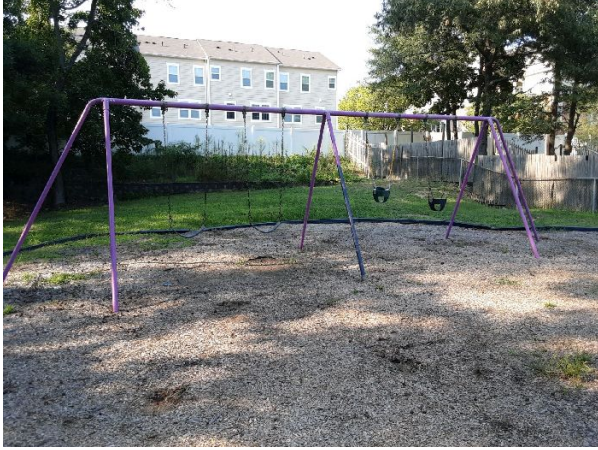
Does equipment have proper use zones?	Yes	●
Are support footings stable and buried below the protective surfacing materials?	Yes	●
Is the swing support structure in good repair, secure with no noted movement?	Yes	●
Is equipment free of openings that can cause entrapments?	Yes	●
Are all moving components free of excessive wear?	Yes	●
Are swing seats in good condition, no cracks, splits or damage?	No	⚠

- Both belt seats have brackets that are cracking, bent and kind of sharp. Replace them.
- One of the tot buckets is intended only for residential use. Replace it.

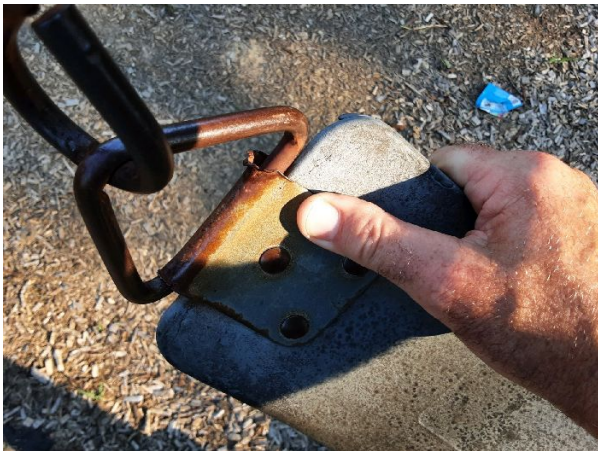
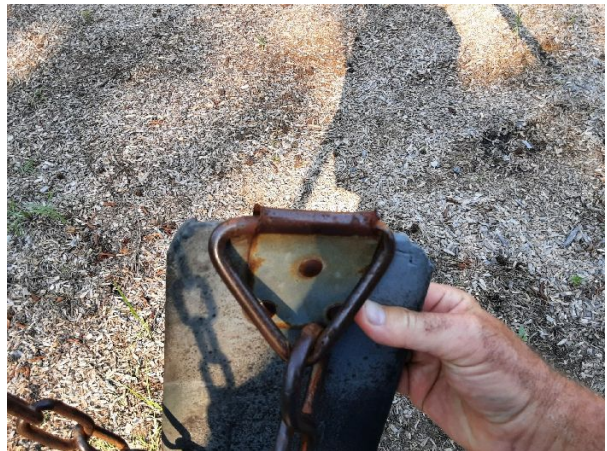
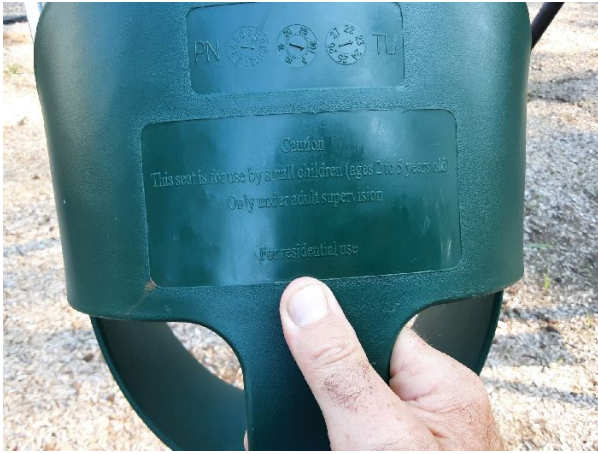
• Six of the eight s-hooks are open, non-compliant and should be replaced with swing shackles.

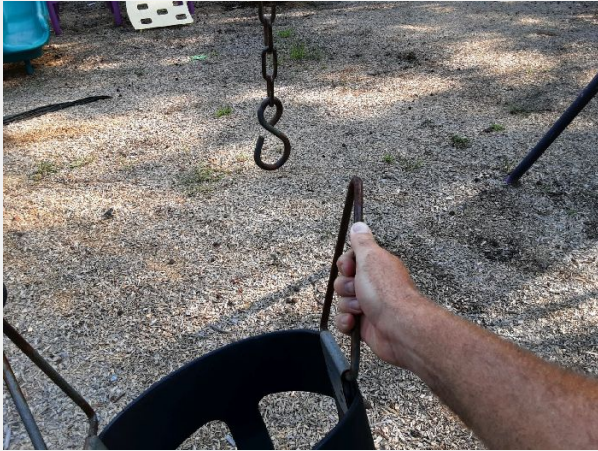
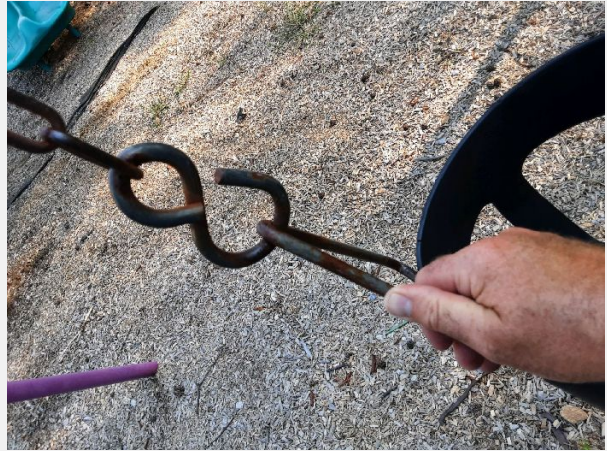
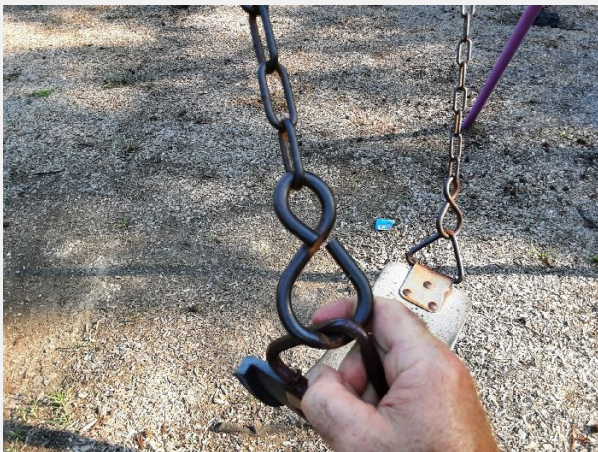
- The (3) non-coated swing chains are showing signs of rust .
- The yellow chain with the residential tot bucket appears to be lightweight, residential chain and has an extra link.

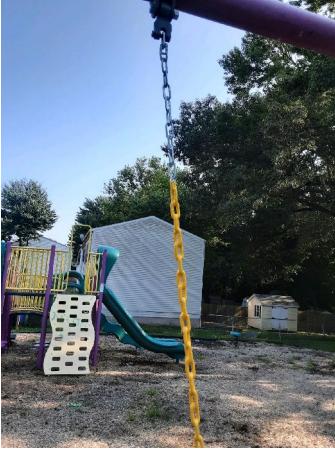
- Damaged paint & rust throughout.

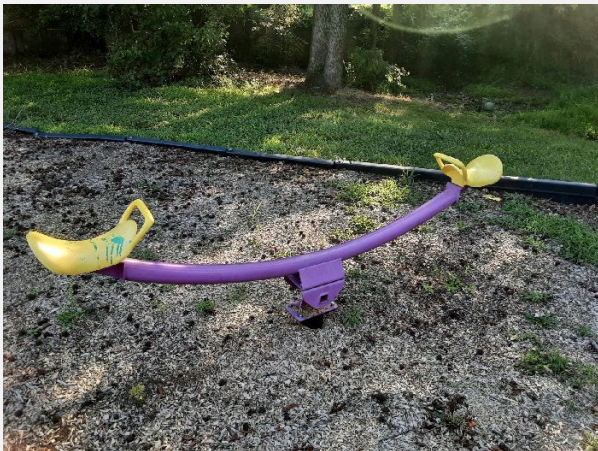
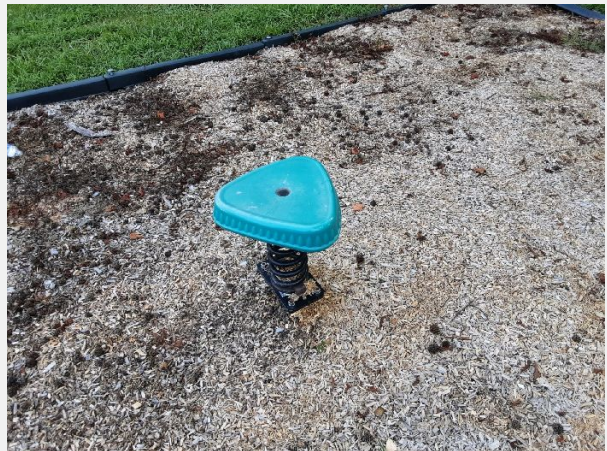
- Paint damage on 2 seat bouncer.

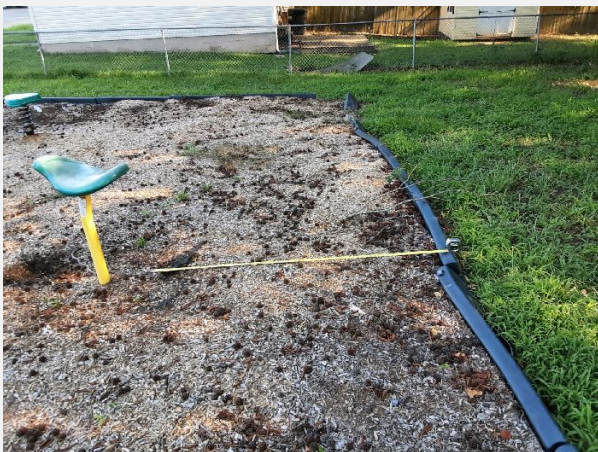
Is the merry-go-round support structure in good repair? Are top portions of the merry-go-round (including support bars, hand holds and other related devices) fully secured with no noted movement?	NA
Is merry-go-round free of any gaps between portions of the platform?	NA
Is equipment free of openings that can cause entrapments?	Yes ●
Are nuts and bolts tight with no wear noted?	Yes ●
Is equipment free of any protrusions (exposed bolts, screws, nuts) or entanglements?	Yes ●
Are the merry-go-round platforms smooth with no damage, openings, rough or sharp edges noted? • The plastic spinner seat has some cuts, dings & nicks in it.	No ⚠
Has the fault been repaired? No	Priority: Low

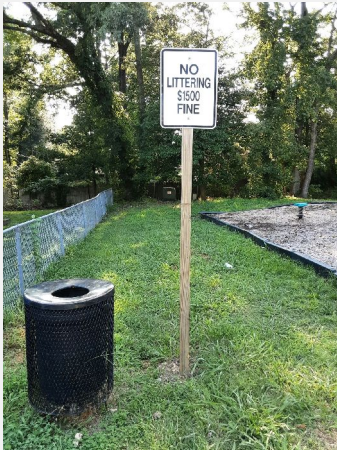
Is playground signage provided, secure and in good condition?
Adult supervision & Age appropriateness recommended?

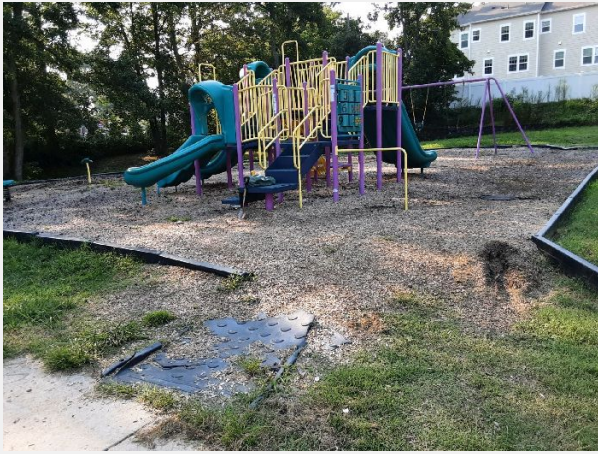
- Measured throughout today to find anywhere from 0" - 5" of surfacing and there's a lot of undulations on site.
- There's weeds & grass, lots of prickly gumballs - the site needs cleaning out, leveling and filling up.

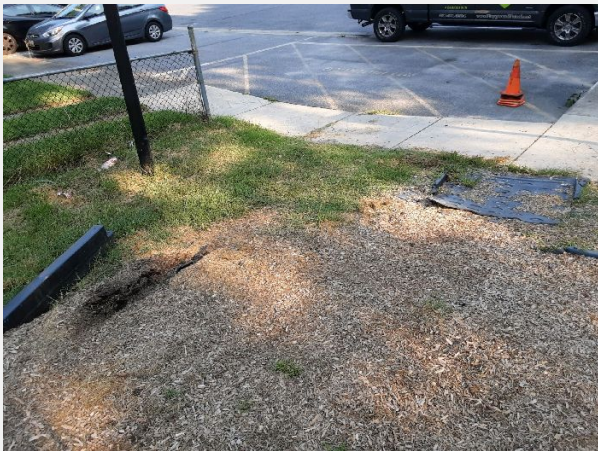
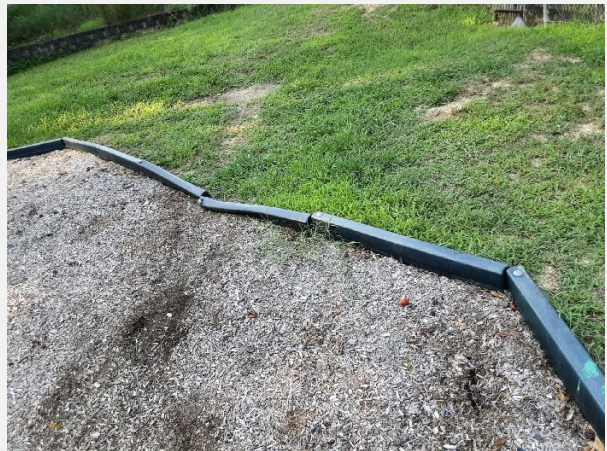
- Borders are crushed, bent & broken throughout the site including at the entrance where there's some missing and what appears to be an access ramp was there at one point now broken apart & crushed.

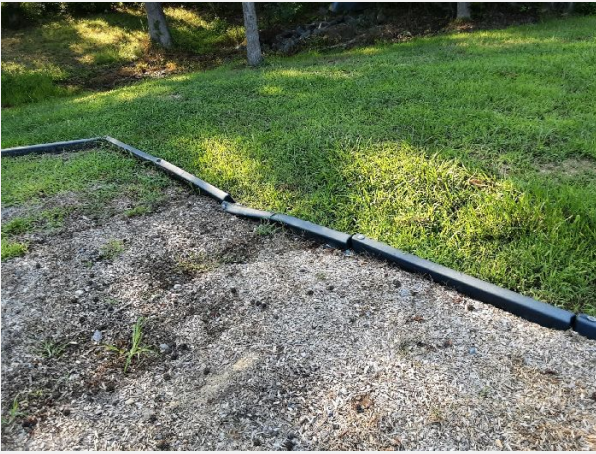
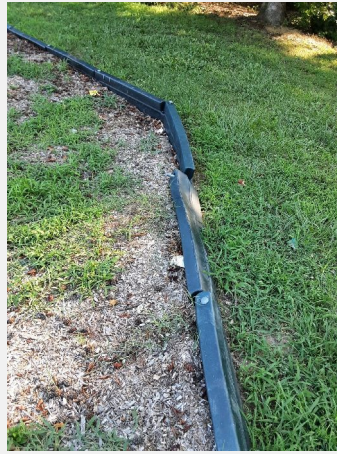
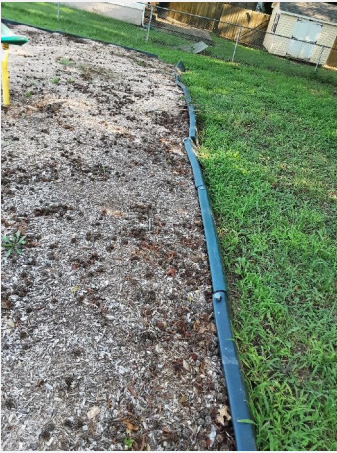
Is the play area free of debris, trash, broken glass, graffiti etc.? Is playground equipment clean?

No

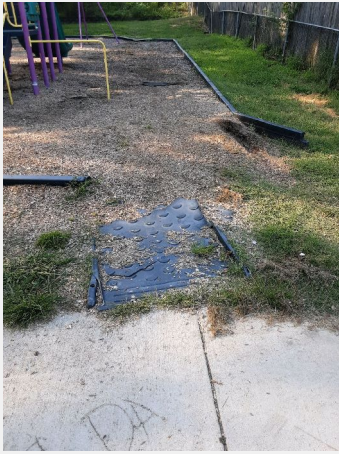
• Community sidewalk to an accessible ramp access that's been damaged.

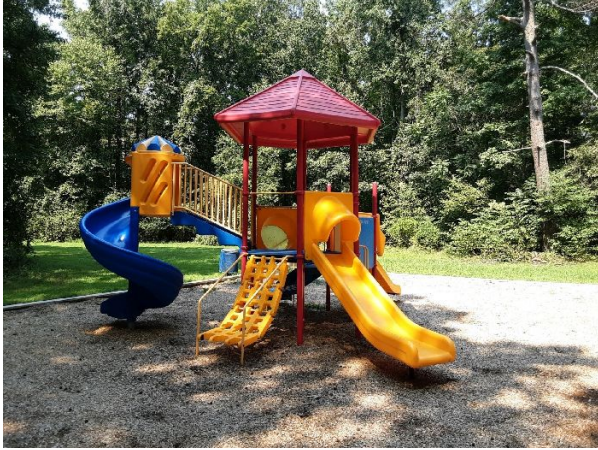
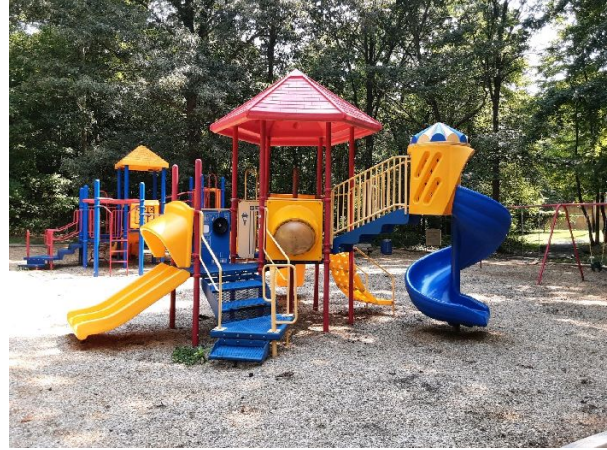
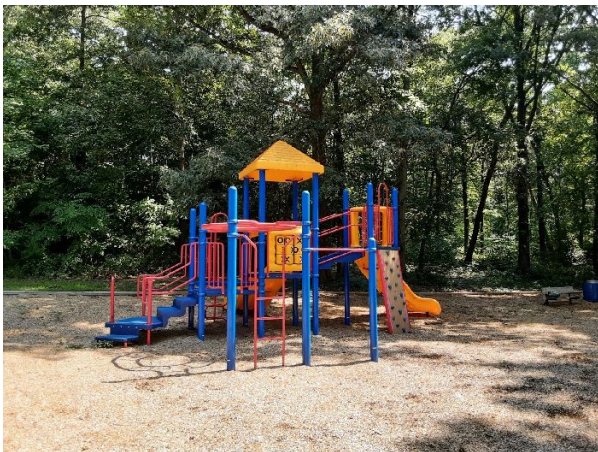
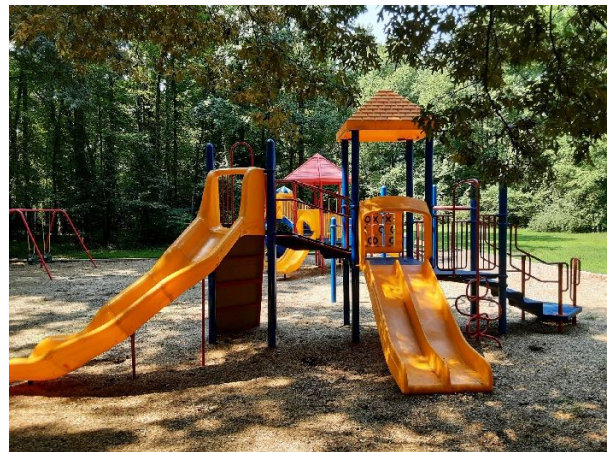
Are warning labels and age appropriate signage present and legible?

No

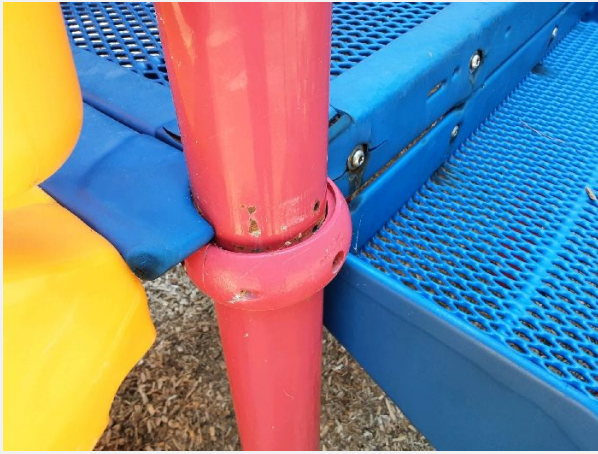
Are platforms and other related areas smooth with no damage, openings or sharp edges noted?

No

• Structure #1: PVC coating on decking & stairs has peeled away exposing delaminated, decomposing rusted metal on both the stairs and the decks.
Has the fault been repaired? No

Priority: Medium

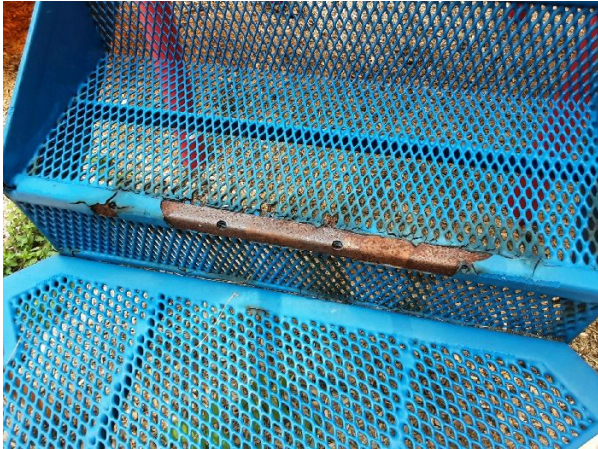
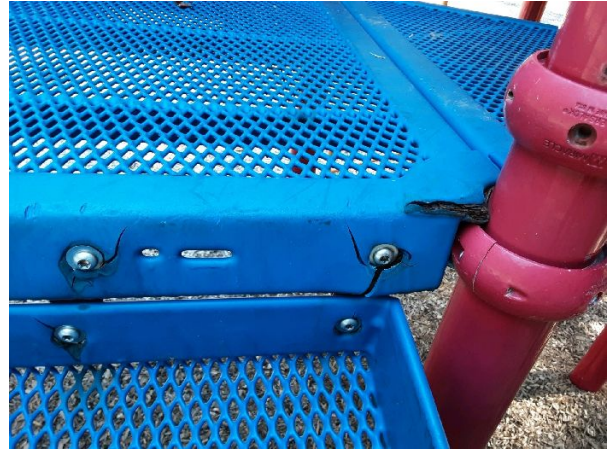
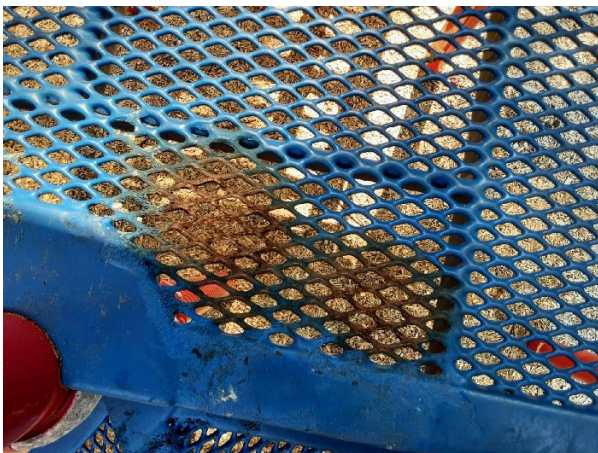
Are platforms and other related areas smooth with no damage, openings or sharp edges noted?

No

- Structure #2: The PVC coating is failing at the top of the Rockwall climb.

Has the fault been repaired? No

Priority: Low

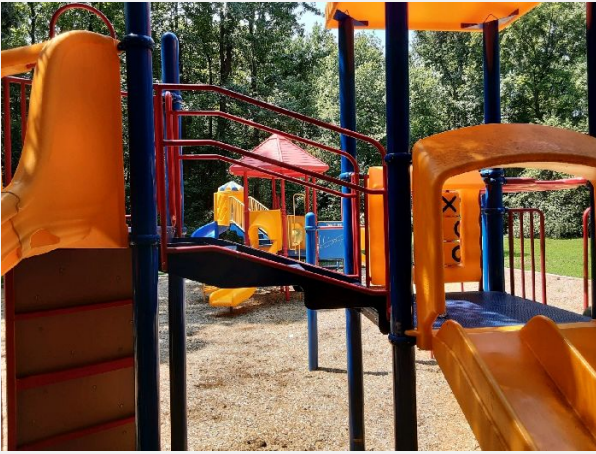
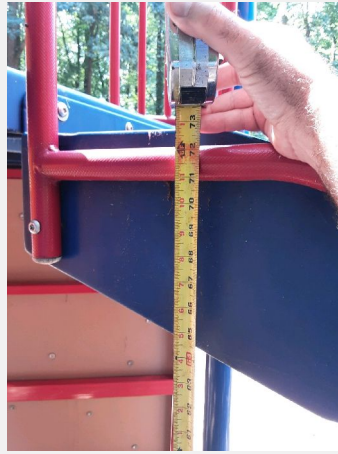
Are access devices to composite play structure (ladders, stairs, etc.) in good condition and secure with no movement noted?

No

• Structure #1: Transfer station access component, as noted above, is not secure, not level and is creating a warp or bend in the deck that it's attached to as well.
Has the fault been repaired? No

Priority: Medium

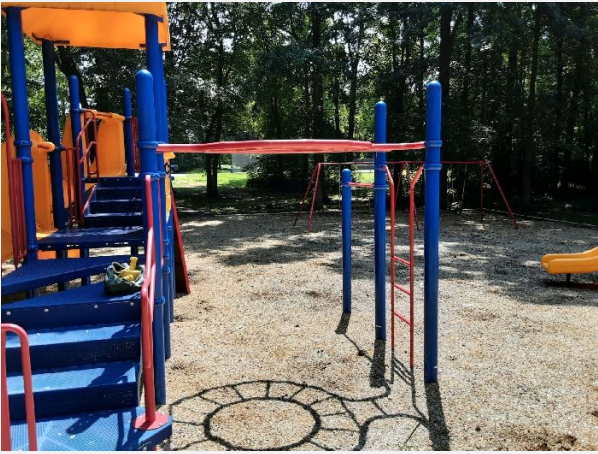
Is equipment free of any protrusions (exposed bolts, screws, nuts) or entanglement hazards?

No

- Structure #1: Protrusions throughout where fasteners are not the original manufacturer provided parts creating protrusion / entanglement or impalement hazards. Has the fault been repaired? No

Priority: Low

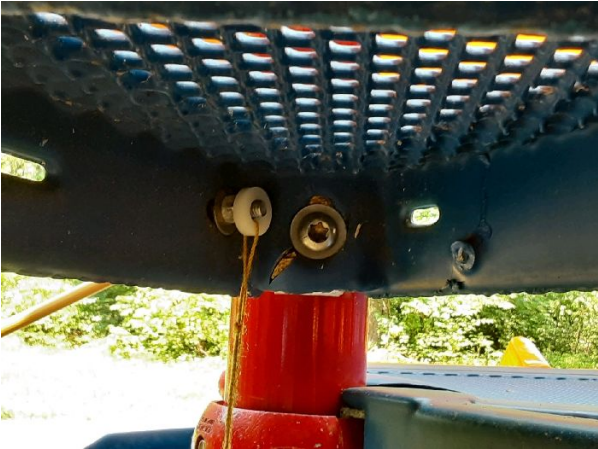
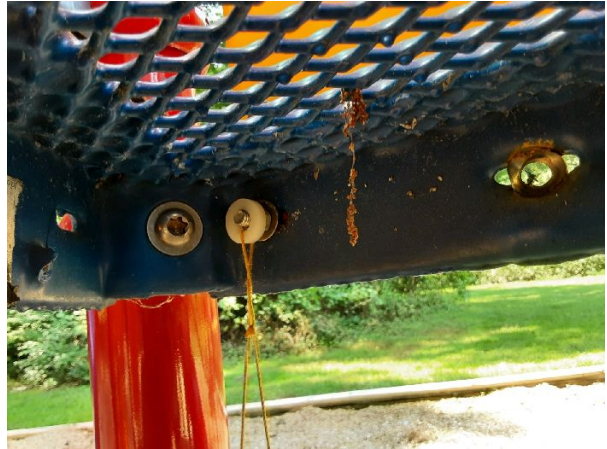
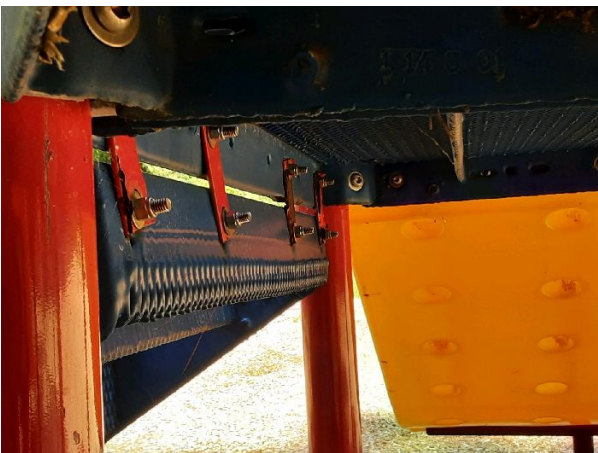
Are nuts and bolts tight with no wear noted?

No

• Structure #1: The mail panel has a loose fastener and a missing fastener on the plastic chain climb and another on a panel where only washer remains.

Priority: Low

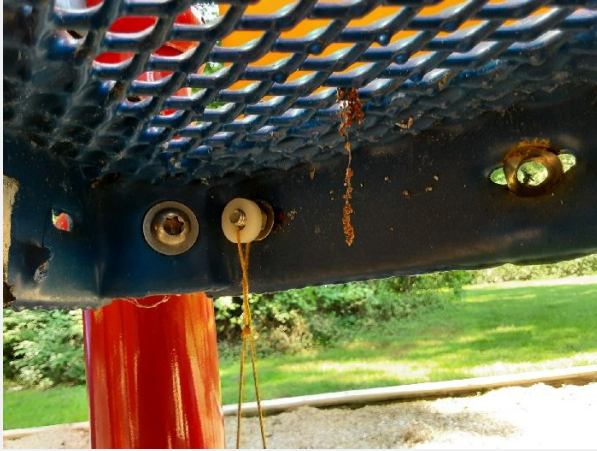
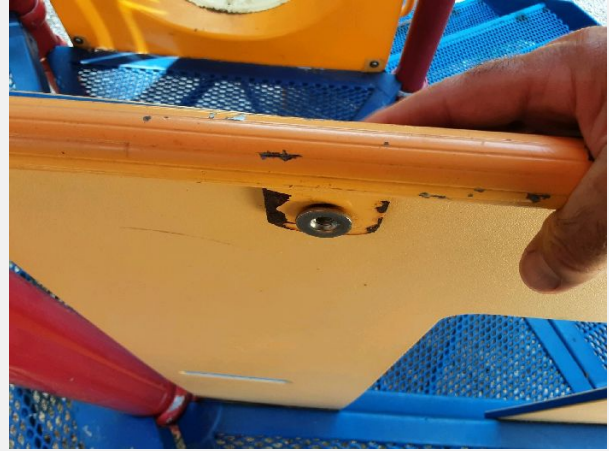
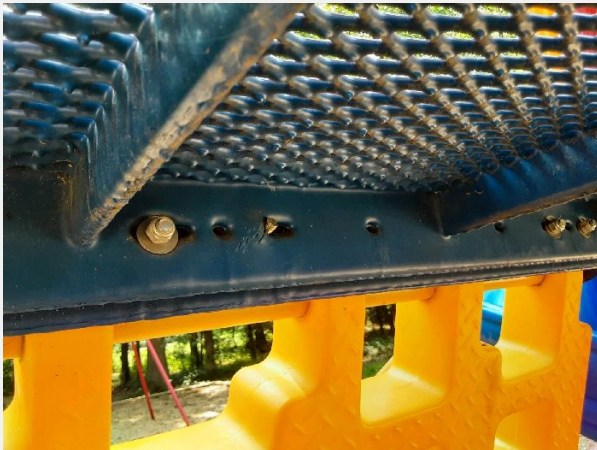
Are plastic components free of cracks or excessive wear?

No

• Structure #1: As mentioned above the bubble panel is damaged.

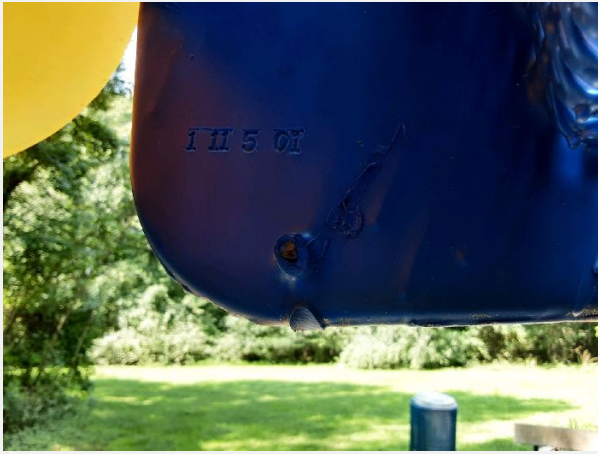
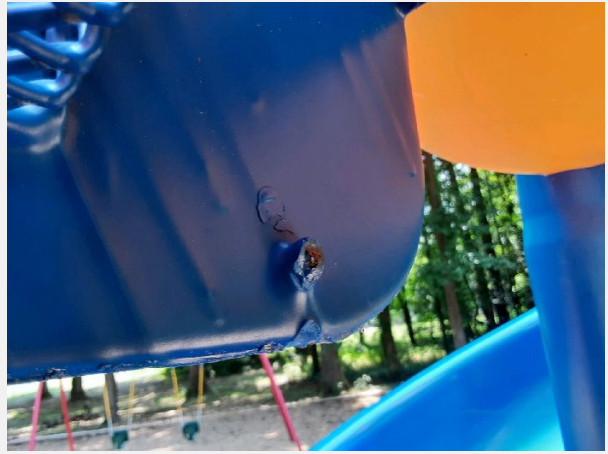
Is equipment free of rust and chipped paint?

No

- Both Structures: Rust noted throughout where PVC has failed on the decking.
 - Structure #1: significant rust throughout the rest of the structure and / or chipped paint.
- Has the fault been repaired? No Priority: Low

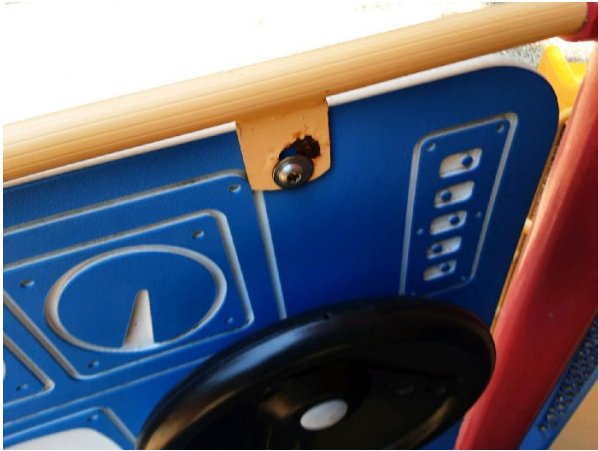
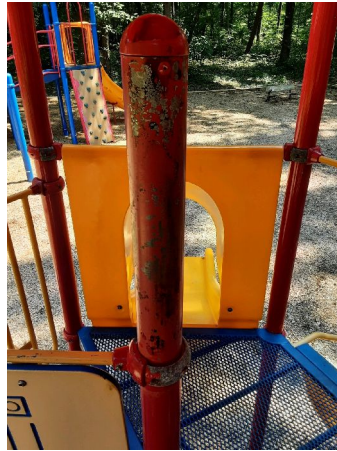
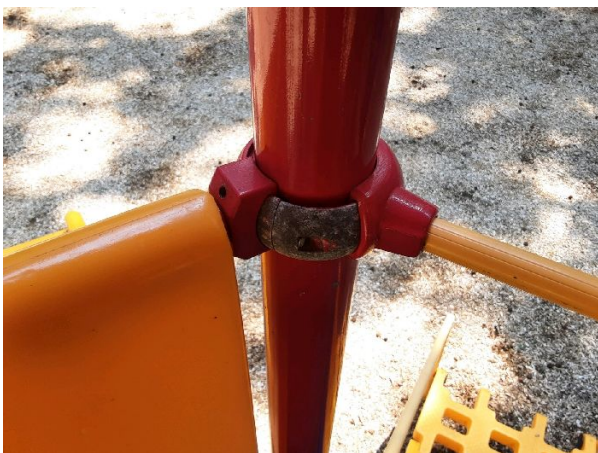
Is equipment free of crush and shear hazards?

Yes

- Structure #1: Missing an end cap on the rails that lead to the spiral slide.

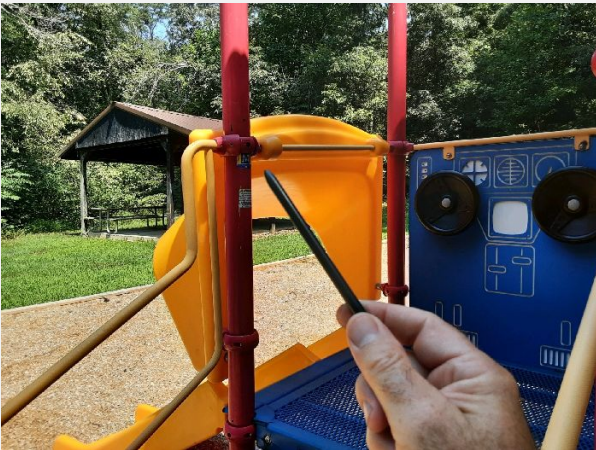
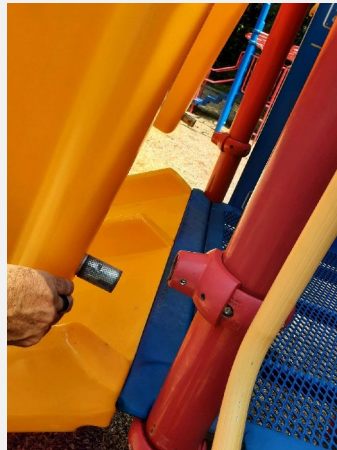
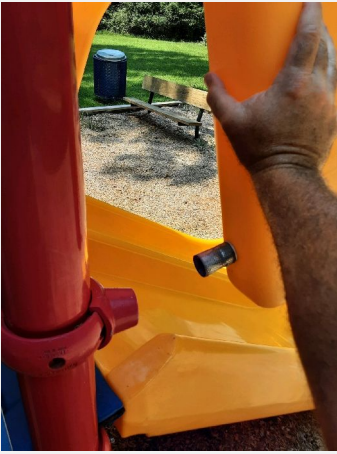
Are top portions of slide including protective barriers, support bars and other related devices fully secured with no noted movement?

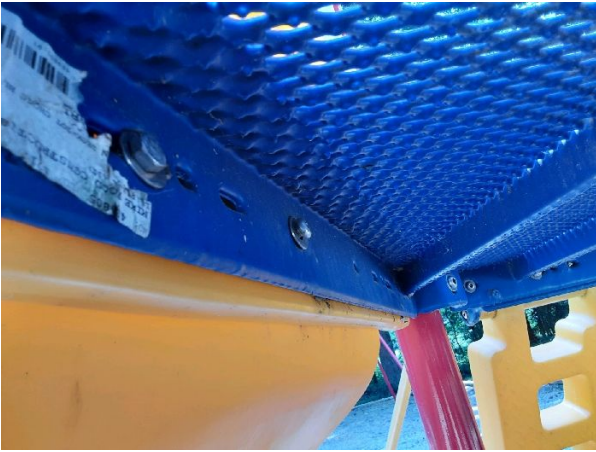
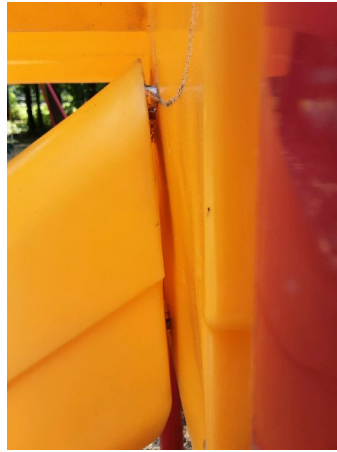
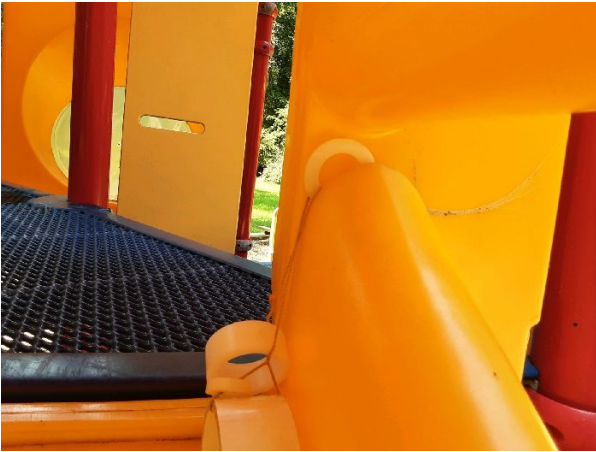
• Structure #1: The straight slide is missing fasteners and has loose fasteners.

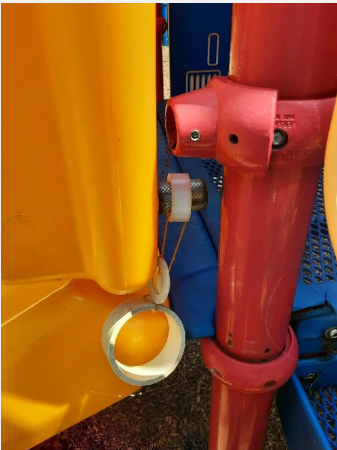
• Structure #1: The loose hood is creating slide entanglements at the protrusion hazards.

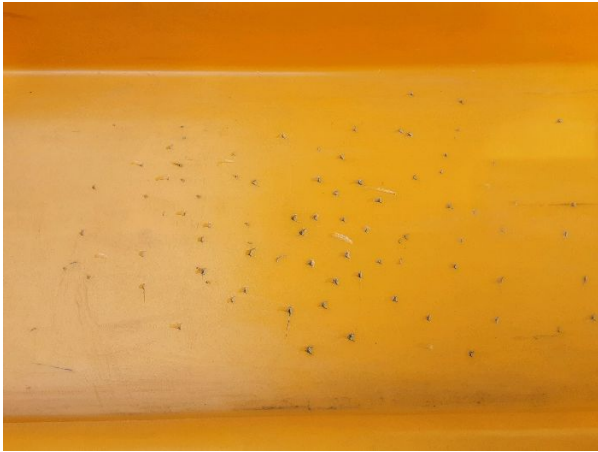
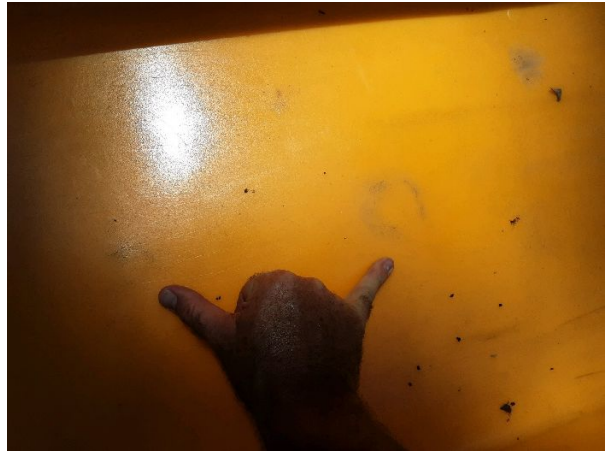
• Structure #1: Straight slide has lots of gouges in the slide bed. None feel sharp to touch. Keep an eye on the vandalism but the slide should likely be replaced. Just based on the trajectory of these facing up when sliding down makes them greater hazards.

• The base of the straight slide is pushing up through the slide causing stress fractures on the slide at the base at the exit.

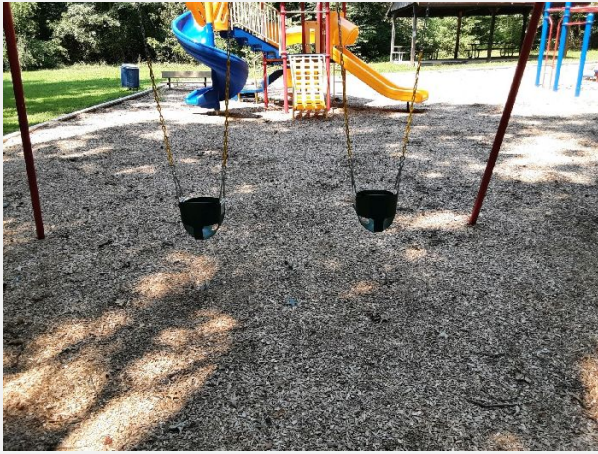
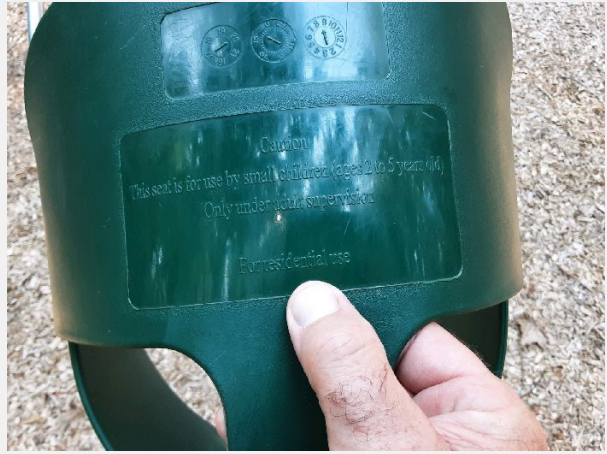
Are swing seats in good condition, no cracks, splits or damage?

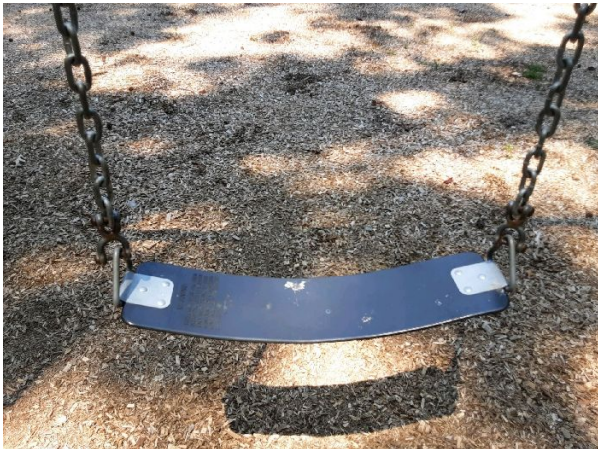
Are swing fasteners (S-hooks, lock devices, etc.) in good condition and fully closed?

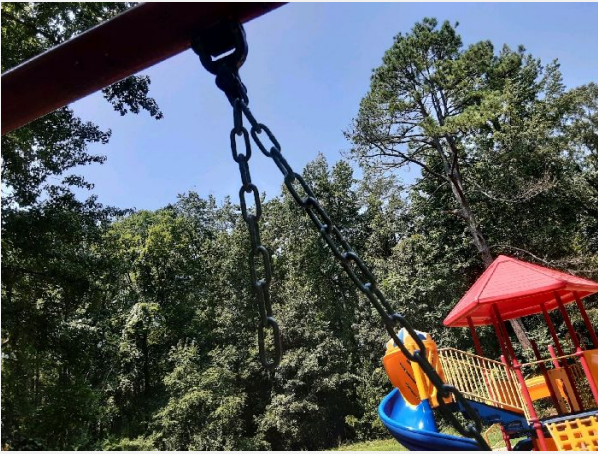
Are swing support chains in good condition with no obvious wear or damage noted?

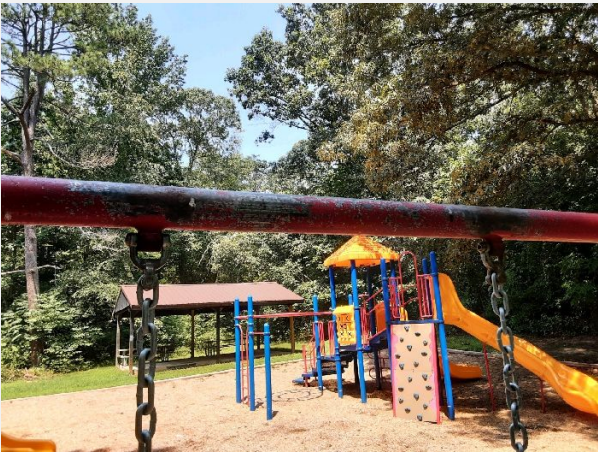
• Quite a bit of rust and missing paint on this unit - particularly across the top beam.

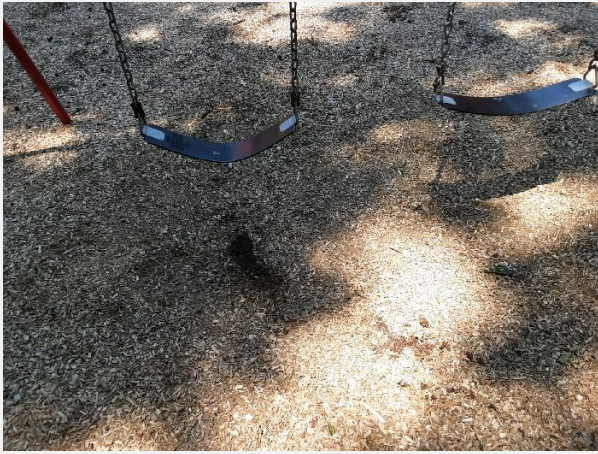
• There are swing ruts under the belt seats with surfacing worn down to the dirt.

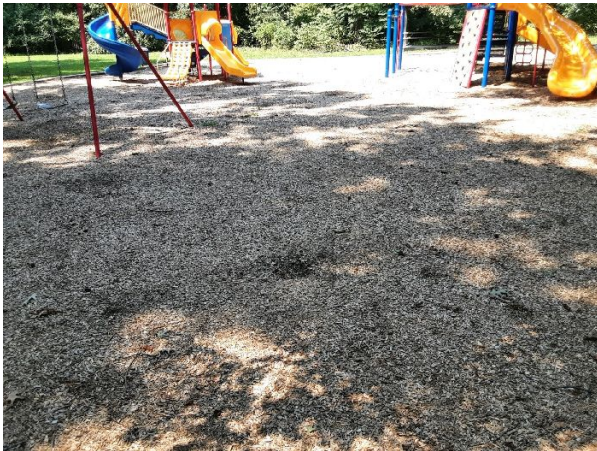
- Measured throughout the today to find anywhere from 2" - 4" of engineered wood fiber over compacted or decomposed organic soil / dirt.

Does protective surface area appear to be in good condition, uniform and appropriate depth (loose fill only)?

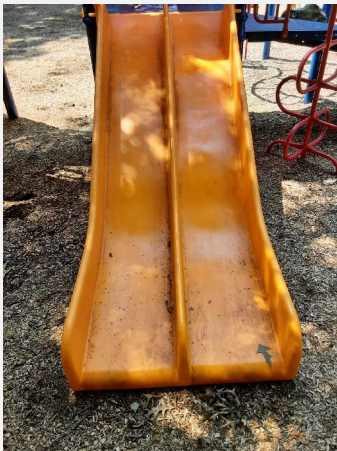
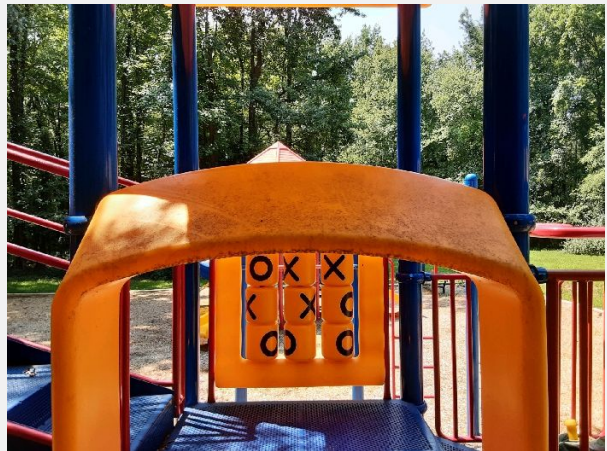
Is the play area free of debris, trash, broken glass, graffiti etc.? Is playground equipment clean?

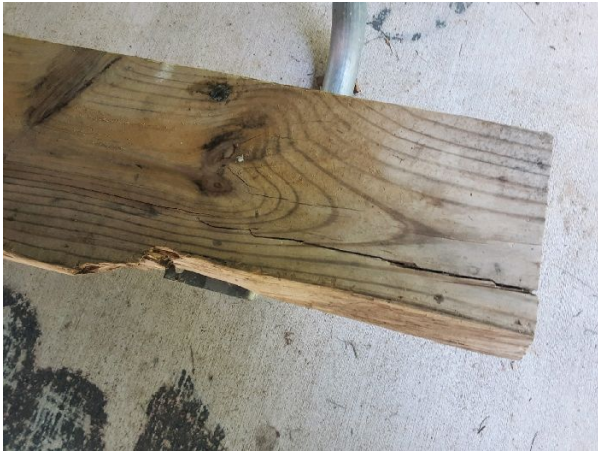
- One (1) picnic table plank is damaged & split so only one anchor on one side.

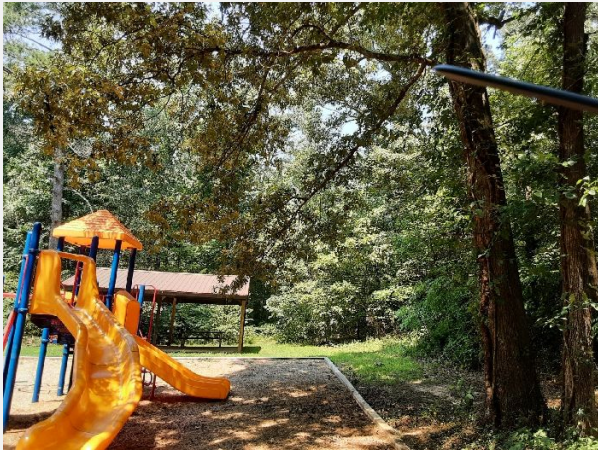
- Tree branches growing into the play area becoming very close to being within 7' feet of the equipment.
 - Currently removing two branches should do the trick.
- Has the fault been repaired? No Priority: Low

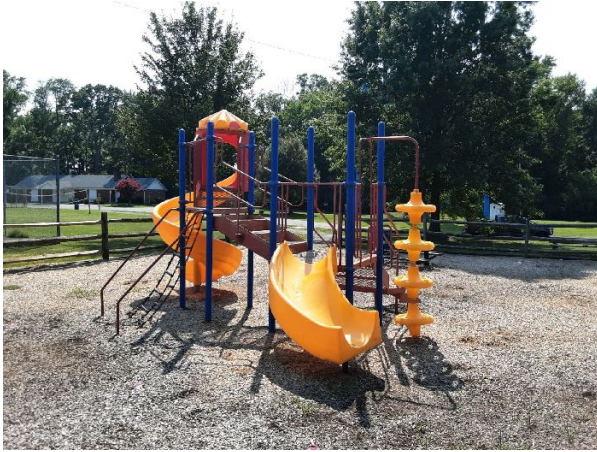
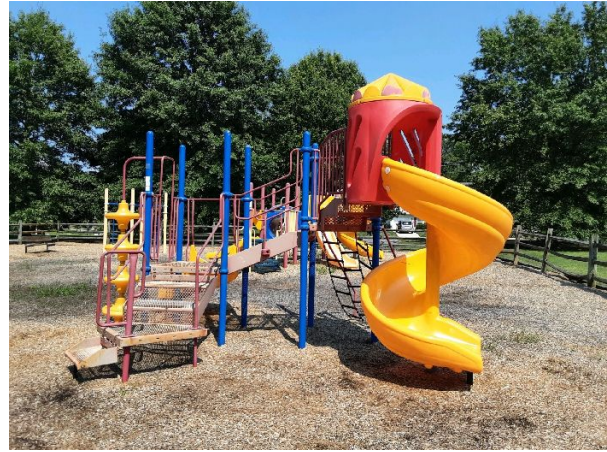
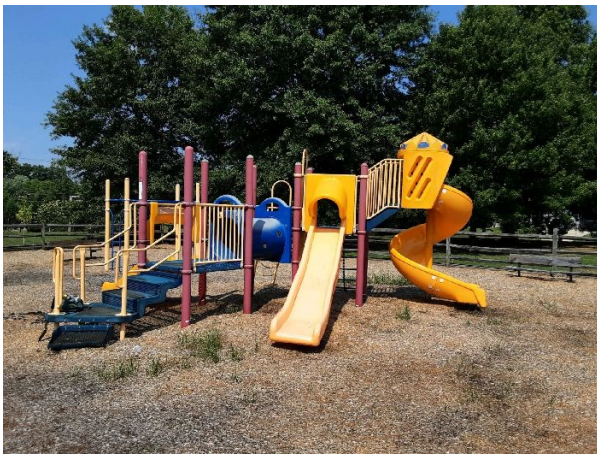
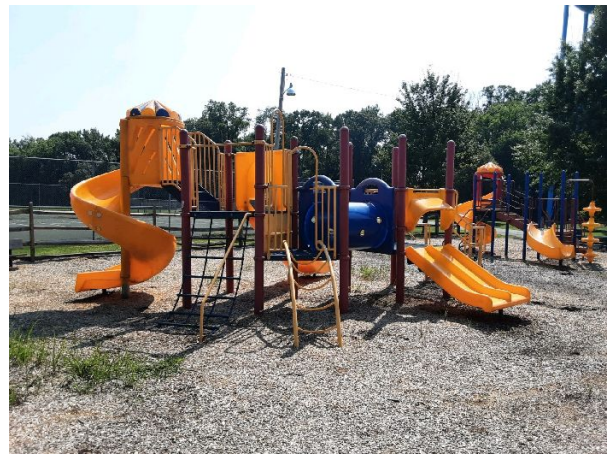
- Structure #1: Two (2) deck structure w/ transfer station, saucer climb, left turn slide, inclined stairs, chain net climb, spiral slide.
- Structure #2: Three (3) deck structure w/ transfer station, driver panel, race slide, crawl tube connector, deep arch climb, chain net climb, wave slide & a spiral slide.
- * NOTE: Both of these pieces are quite dated and have general design non-compliances. Structure #1 in particular is failing structurally as well.

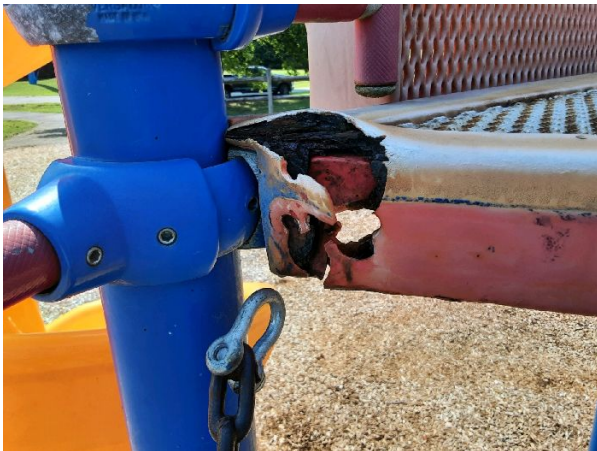
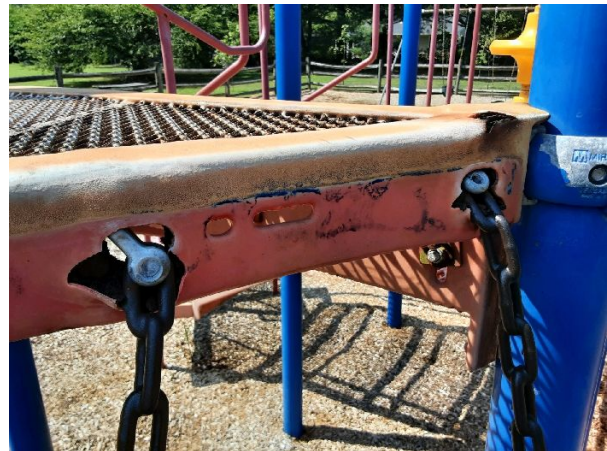
- Does equipment have proper use zones? Yes ●
- Is equipment free of openings that can cause head entrapments? Yes ●
- Are support footings stable and buried below the protective surfacing materials? Yes ●
- Is the composite playset support structure in good repair, secure with no noted movement? Yes ●
- Are platforms and other related areas smooth with no damage, openings or sharp edges noted? No ▲

- Platforms are disintegrating in places in particular at the chain net climb.
- One of the three openings has completely failed and the other three I have also failed as well so that if I worked hard enough I could pull them out completely. Almost coming out with just with my weight on them.

Priority: Medium

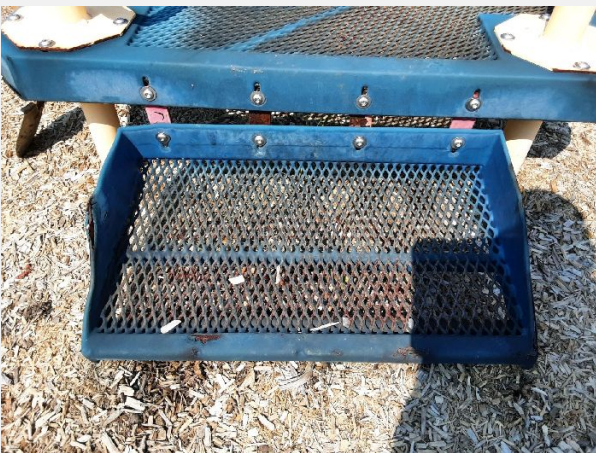
Are platforms and other related areas smooth with no damage, openings or sharp edges noted?

• Structure #2: The stairs on the transfer station is failing. The others are beginning to fail but the riser and the stairs on the transfer station are already happening. Has the fault been repaired? No

Priority: Low

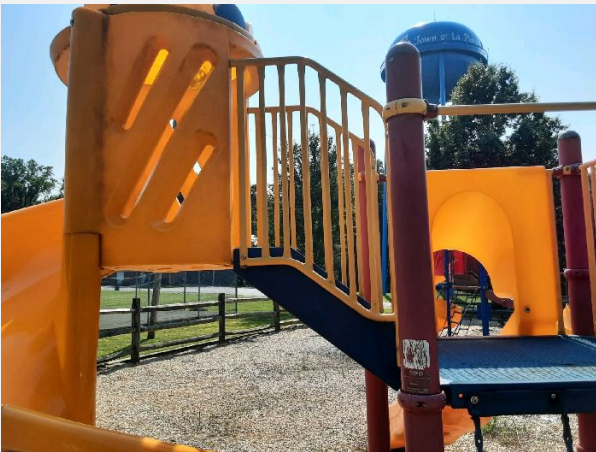
Are access devices to composite play structure (ladders, stairs, etc.) in good condition and secure with no movement noted?

- Structure #1: As noted above, the chain net climb is pulling right through the deck. One of them has already broken the other two can go at any moment.

Priority: Medium

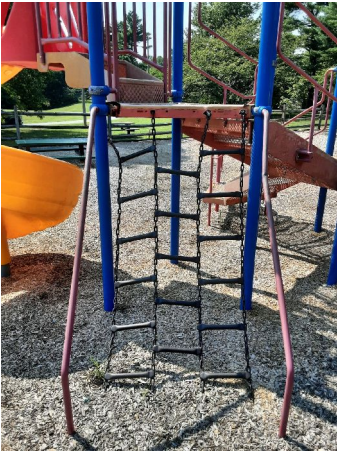
Are access devices to composite play structure (ladders, stairs, etc.) in good condition and secure with no movement noted?

• Structure #2: The net climb on structure #2 is also failing at the top where it mounts to the deck.

Priority: Low

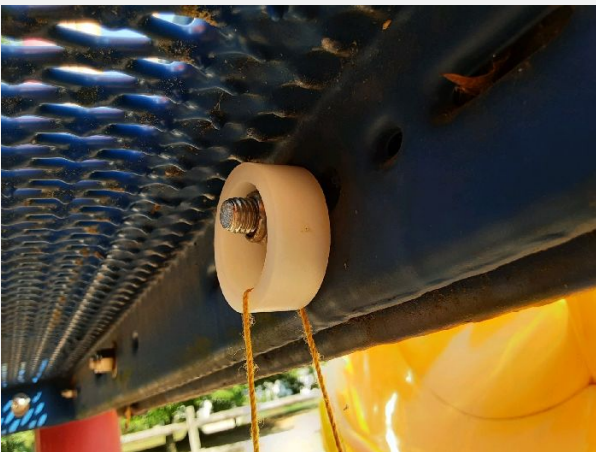
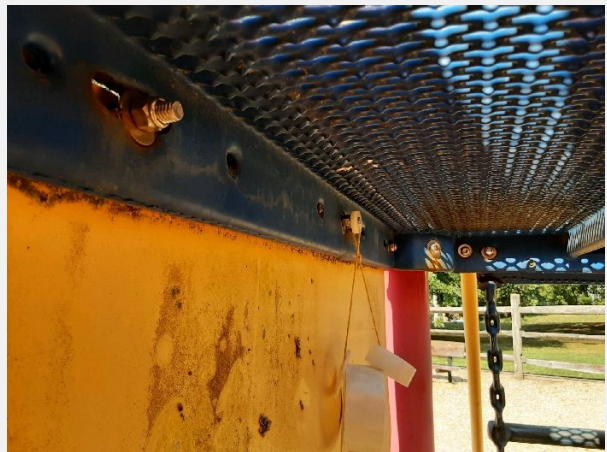
Are nuts and bolts tight with no wear noted?

• As noted above, there are some loose fasteners in the sense that the chain net is not installed per the manufacturer's recommendations - it's got swing clevises & they're not secure.

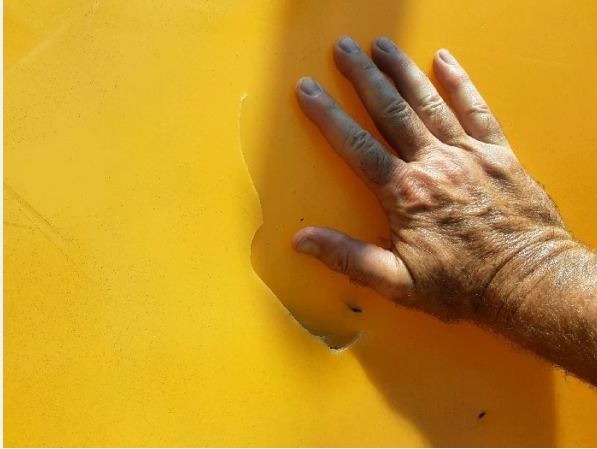
Are plastic components free of cracks or excessive wear?

• Left turn slide has a large crack in it.

Priority: Medium
