**Parks and Recreation Commission
Regular Meeting
April 8, 2026, 8:00 AM
Meets virtually via Microsoft Teams**

TOWN OF LA PLATA
Parks and Recreation Commission Minutes
January 14, 2026, 8:00 AM
Regular Meeting
Meets virtually via Microsoft Teams

Park	Address / Location	Year Built	Owner	Foundation Condition	Equipment Condition	Measurements / Square Footage (internal area)	Equipment Manufacturer	Signage	Notes
Wills Park	503 St Mary's Ave	1984	Town	Poor	Poor / Safety Issues	97 x 77 = 7,469		hrs and restrictions	Full playground upgrade FY2026. Walkway - 205 linear sq feet, future improvement need
Clarks Run	End of Silver Linden Dr	1983	Town	Fair	Good	77 x 70 = 5,390	It's a Miracle	hrs, restrictions, safety	Suggest PIP and equipment upgrade - 2029
Agricopia	Across from 1037 Crop Pl	2000	Town	Good	Very Good	72 x 48 = 3,456	Eagle	hrs, restrictions, safety	Suggest PIP and equipment upgrade - 2030; or when needed
Caroline Dr (2) - Tot Lot	End of Caroline Dr	1990	Town	Poor	Poor	54 x 30 = 1,620		hrs and restrictions	Suggest we remove and not replace. Playground now adjacent to La Plata Pkwy. If Town invests, we should only invest in large Caroline Dr park.

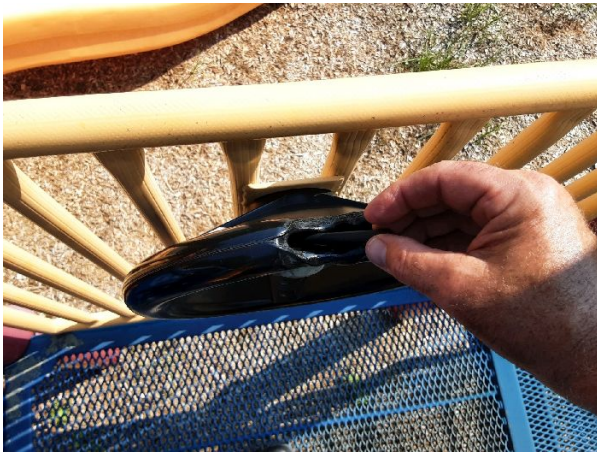
Are plastic components free of cracks or excessive wear?

• Structure #2: The driver wheel has been burned to the point where it's got a hole in it - a good place for stinging insects to nest.

Priority: Low

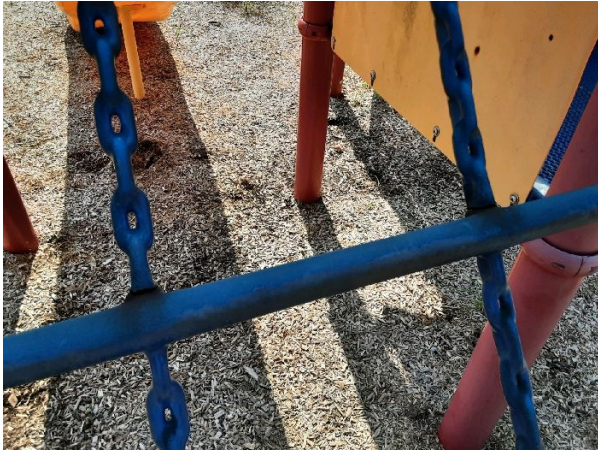
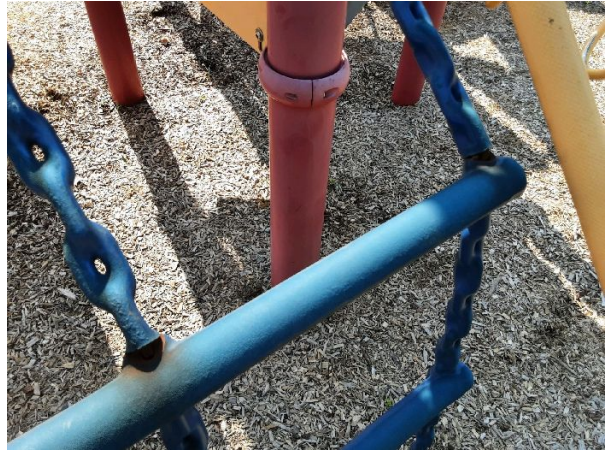
Are chains and / or cables in good condition and not worn out?

• Structure #2: chain net climber has cracks in the pvc coating and rust visible.
Unable to determine the structural integrity of the coated chain but based on what I can see it needs replacement.

Priority: Low

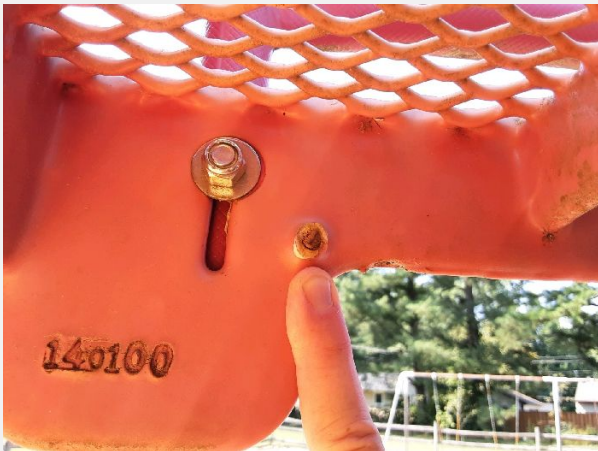
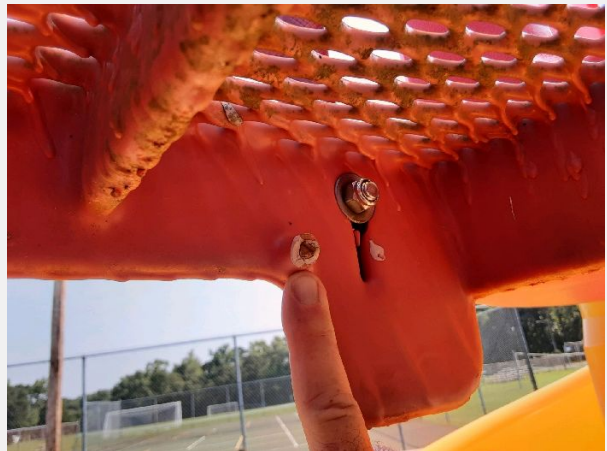
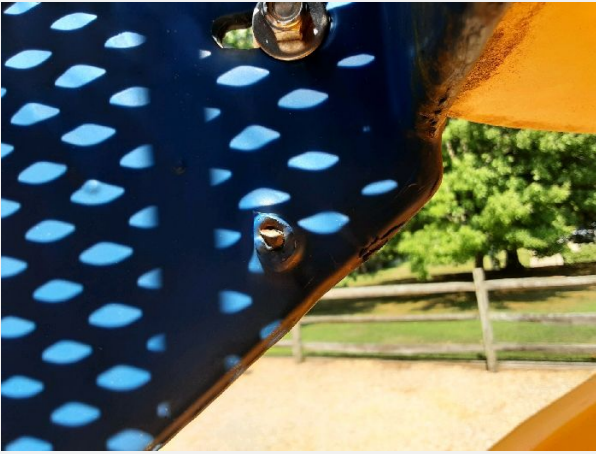
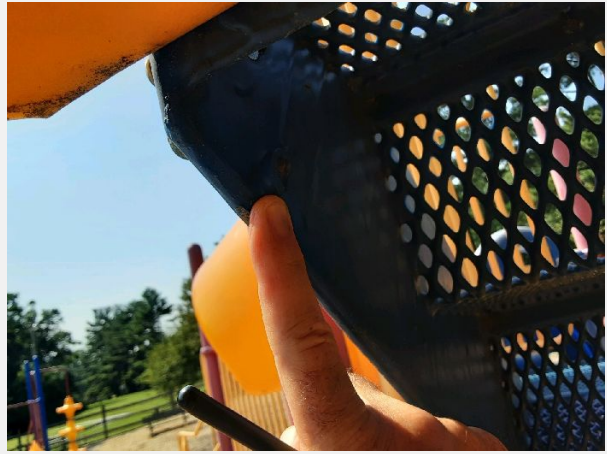
Is equipment free of sharp edges or rough surfaces?

• Where the decking is degraded there's potential for rusty laceration hazards. In addition to that, underneath the stairs to the spiral slide there are sharp points on both structures.

Priority: Low

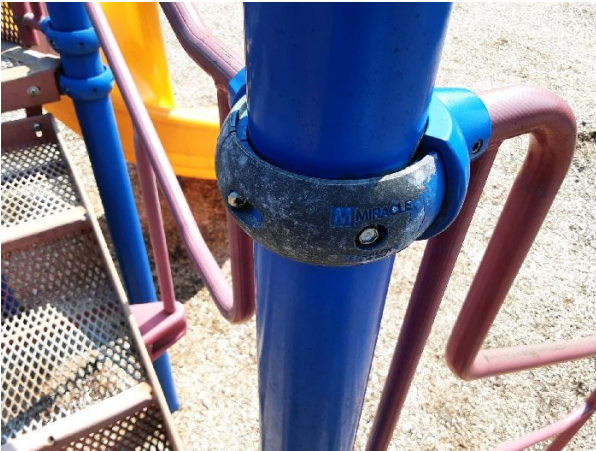
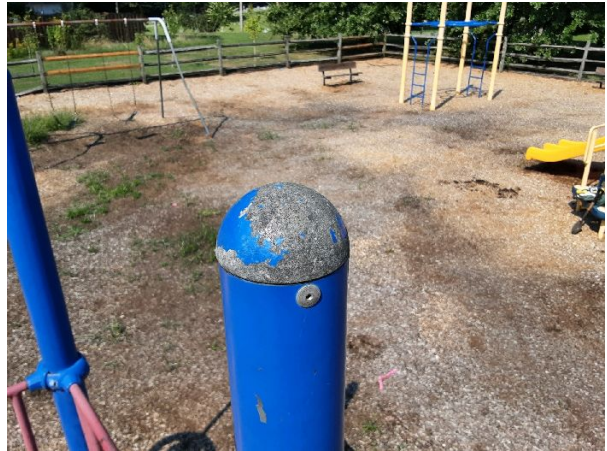
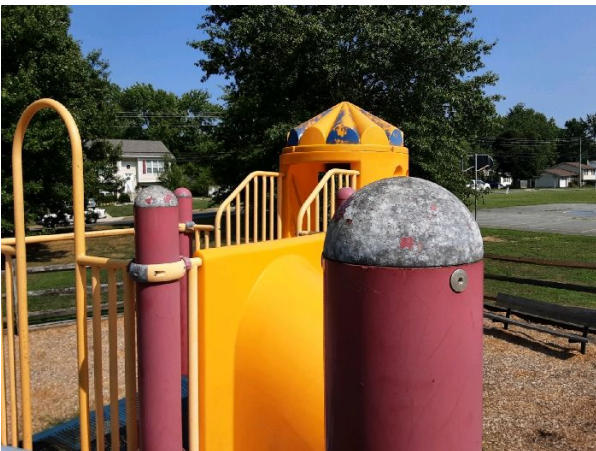
Is equipment free of rust and chipped paint?

• As noted throughout, there's plenty of rust on this old equipment & there is chipped paint on both.

Priority: Low

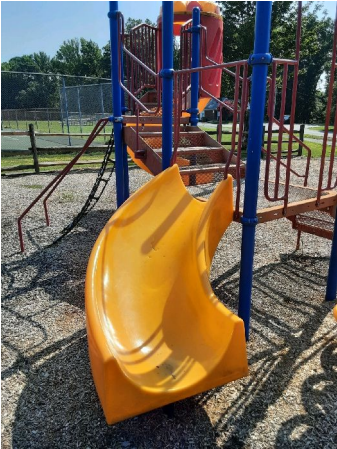
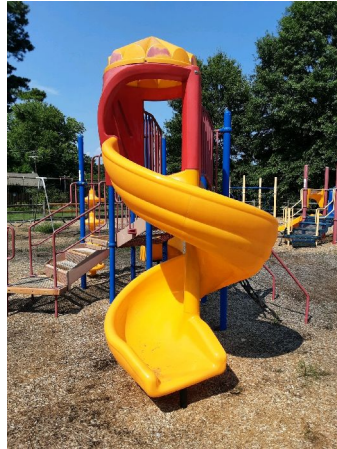
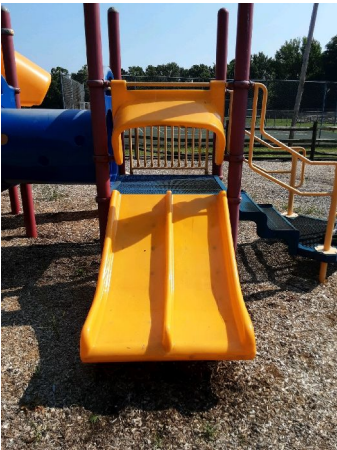
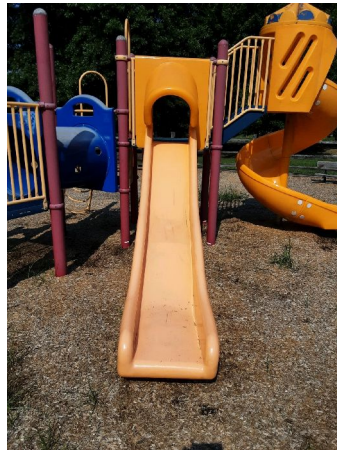
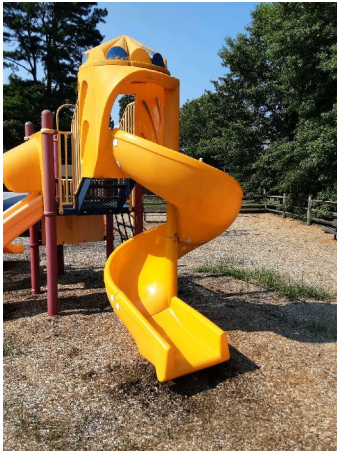
Structure #2:

- Wave slide off 56" high deck.
- Spiral slide off 76" high deck.

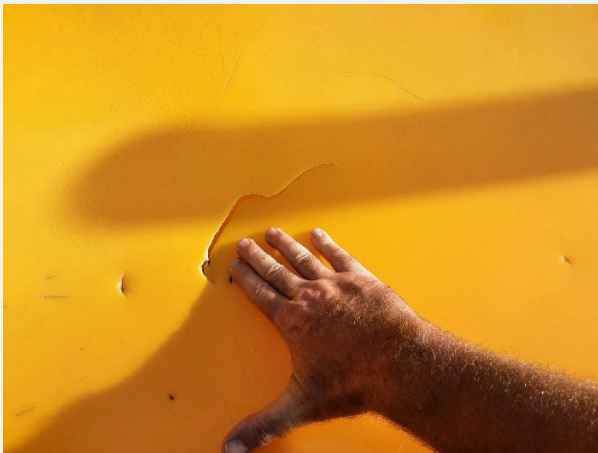
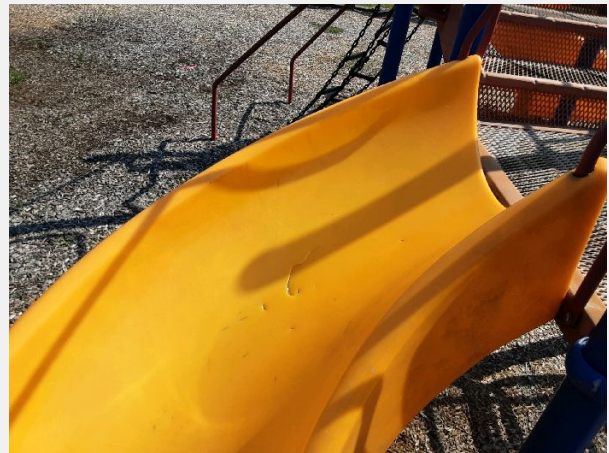
• Left turn slide has a gouge & crack in it facing the direction where somebody could actually rip their flesh coming down the slide.

Priority: Medium

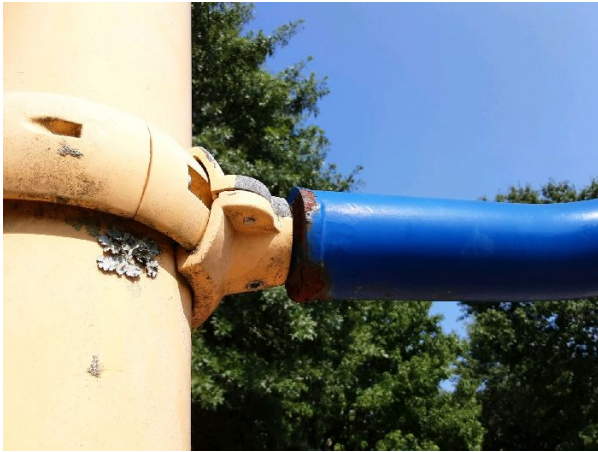
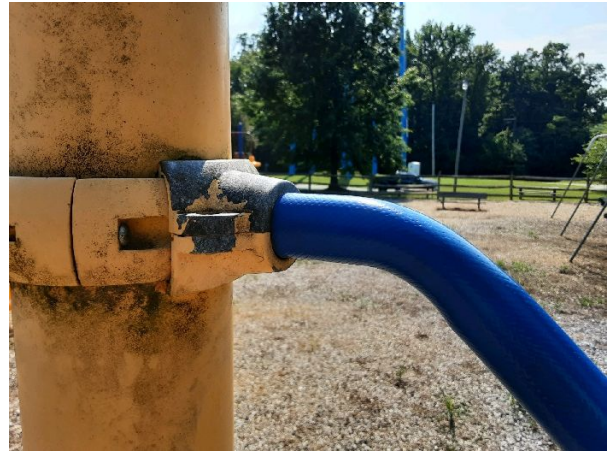
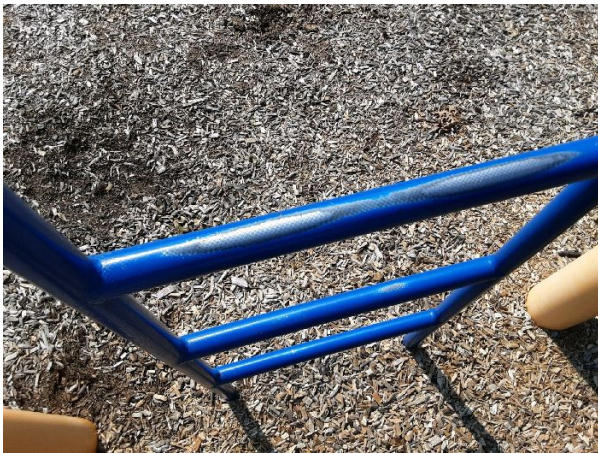
• Chipped paint & rust present. Pay particular attention to when on welds.

Priority: Low

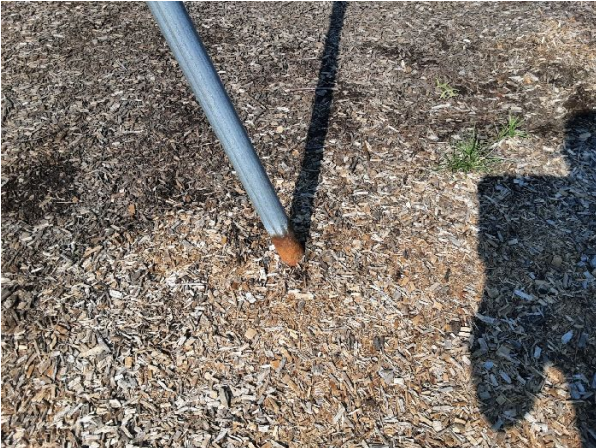
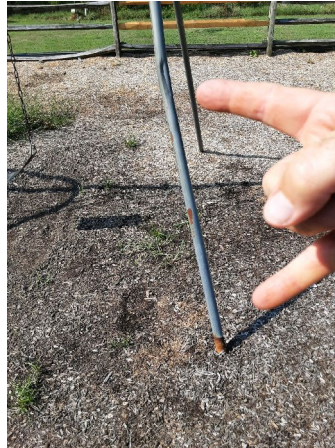
• The footings themselves seem to be okay because there is no movement in the swing when in use though there is rust at the surface and one of the uprights is bent - so the structural integrity is in question.

Priority: Low

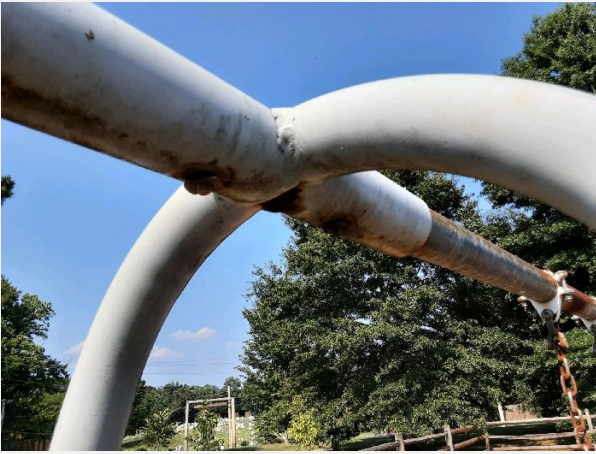
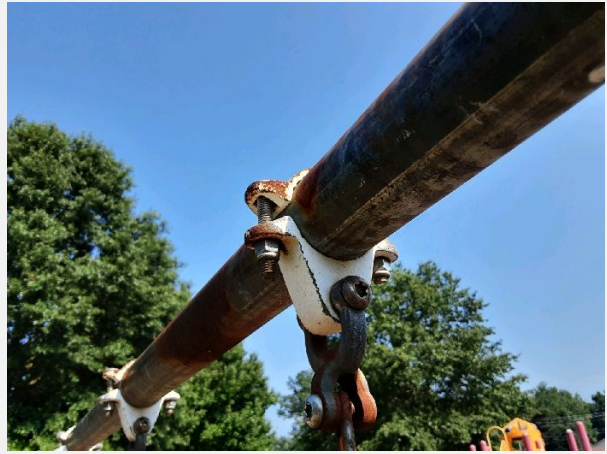
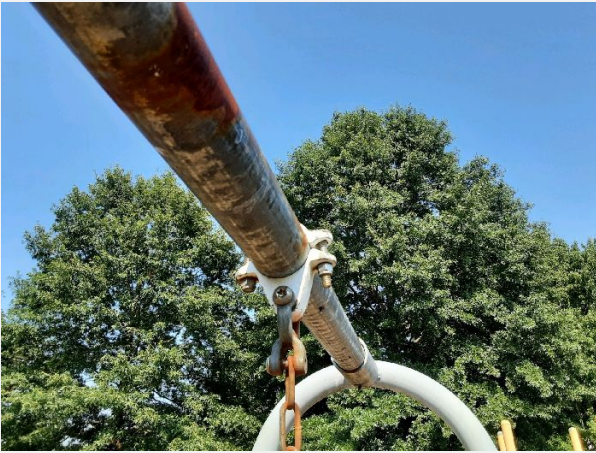
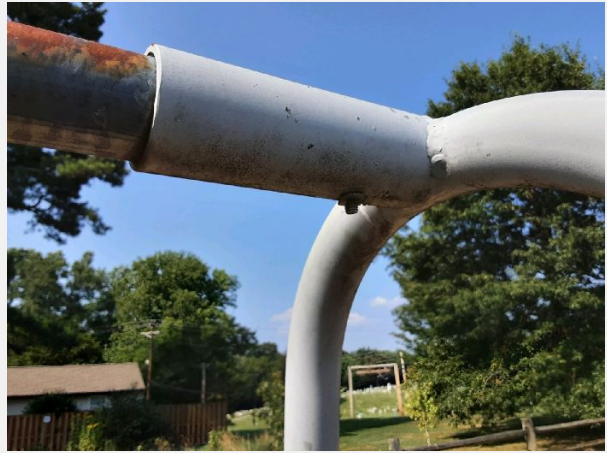
• See directly above, plus rust on welds on the frame.
• Bolt protrusions (more than 2 threads exposed) throughout the unit.

Priority: Low

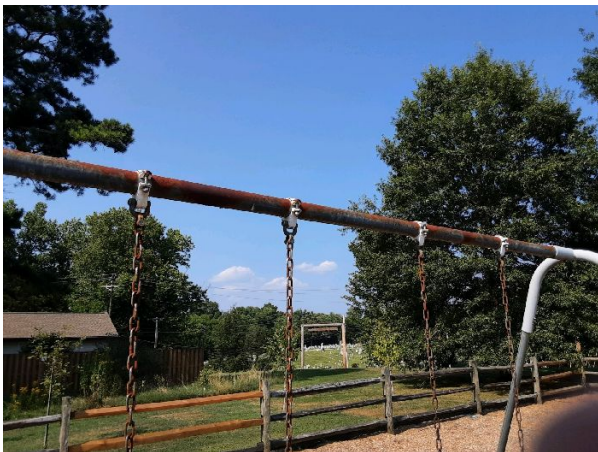
• Rust present across the top beam.

Priority: Low

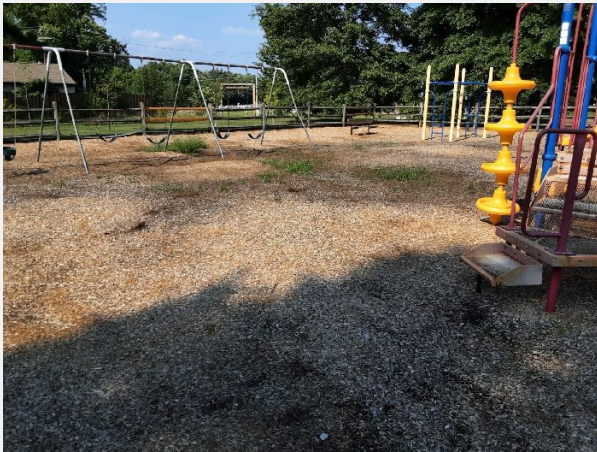
- Measured throughout today to find anywhere from 0" - 5" - but average depth was more like 2" - 3.
- There's lots of grass and weeds and the site itself has a lot of undulations and is not level.

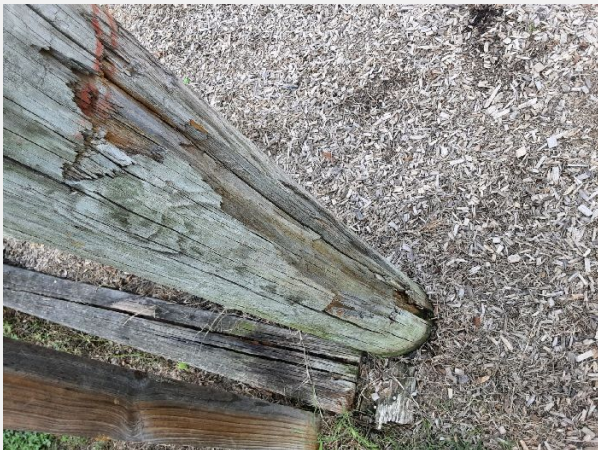
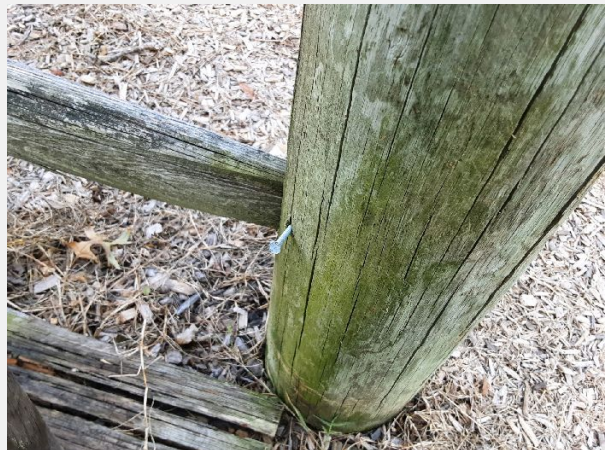
• Found trash and debris in & around the play area today and there's some vandalism on the equipment.

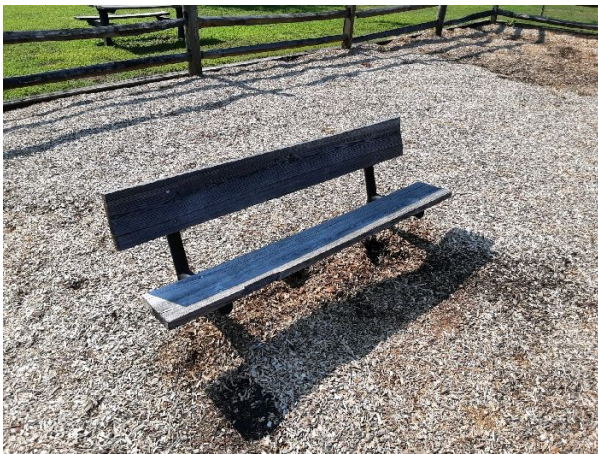
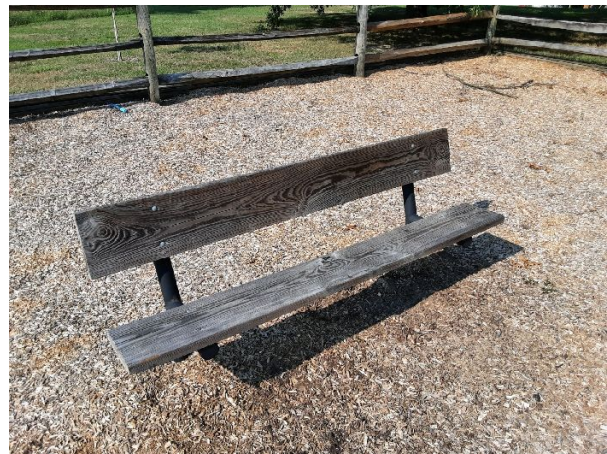
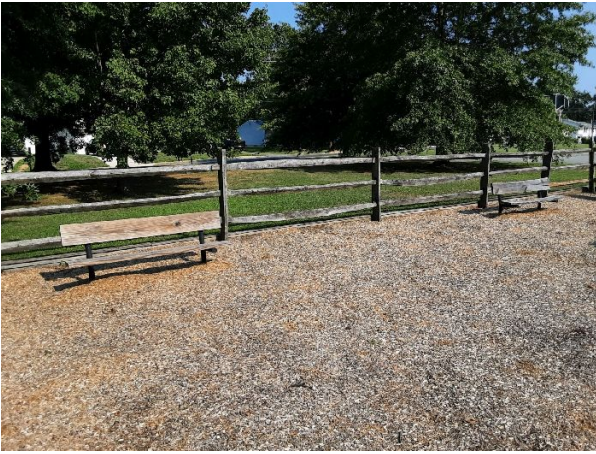
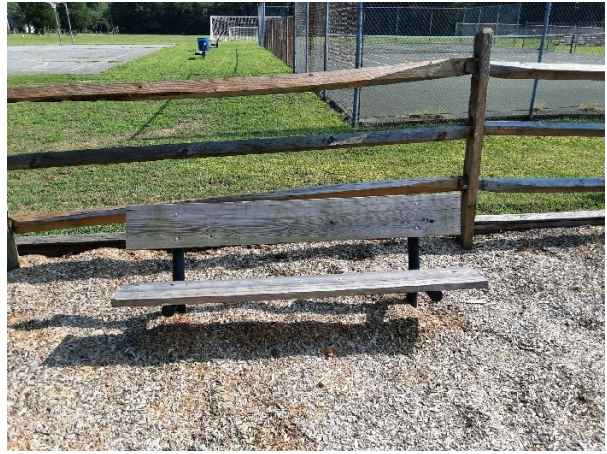
Are benches clean, in good condition and secure with no exposed bolts or sharp edges?

- Two (2) planks on the benches are damaged. One on the back one on the seat.
- A few have bolts are too long underneath which are impalement hazards.

Priority: Low

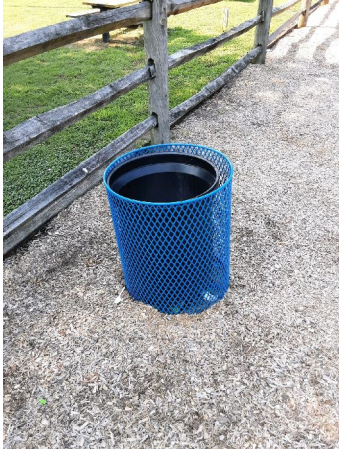
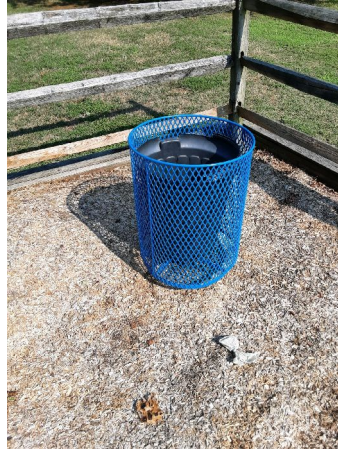
Pictures of garbage can area

- Two (2) poly coated trash receptacles without tops and a liner.

Are garbage cans / receptacles clean, in good condition and secure?

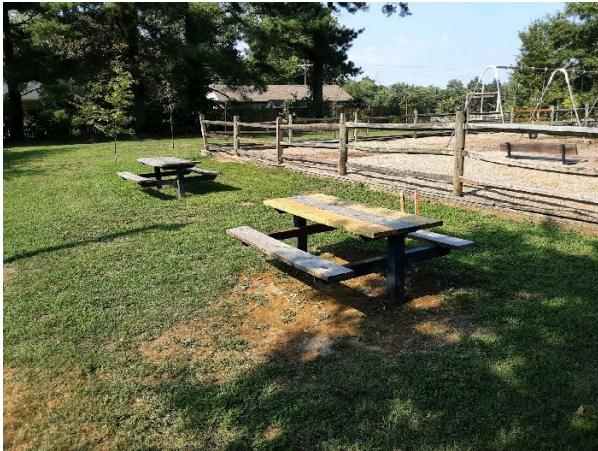
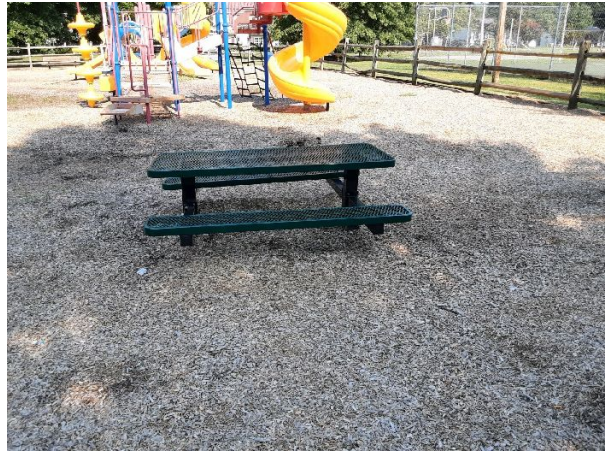
Are picnic tables clean, in good condition and secure with no exposed bolts or sharp edges?

- Long bolts underneath could be impalement hazards.

Priority: Low

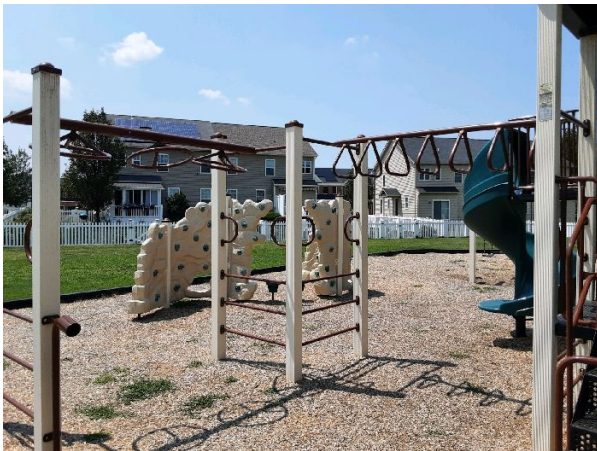
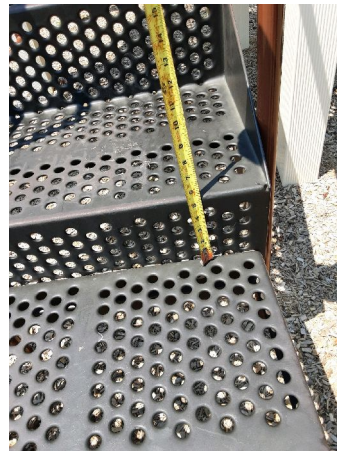
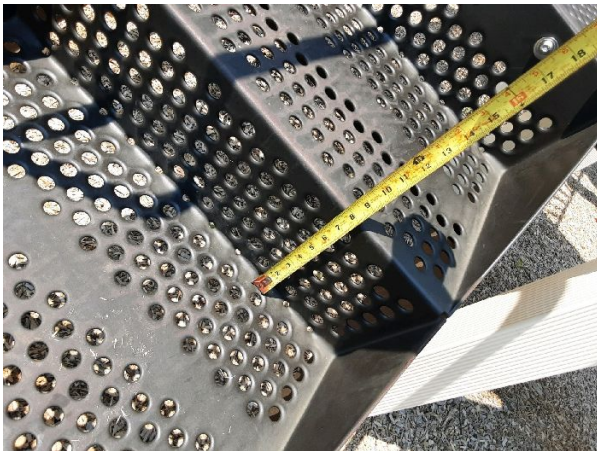
Is equipment free of any protrusions (exposed bolts, screws, nuts) or entanglement hazards?

- One fastener set missing on slide sit down panel.

Priority: Medium

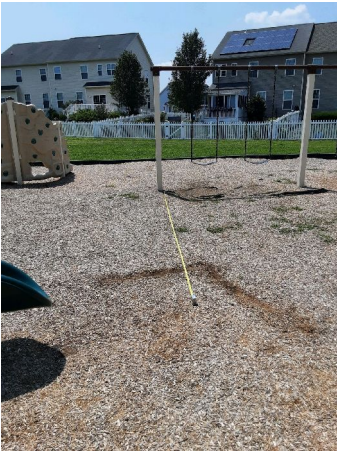
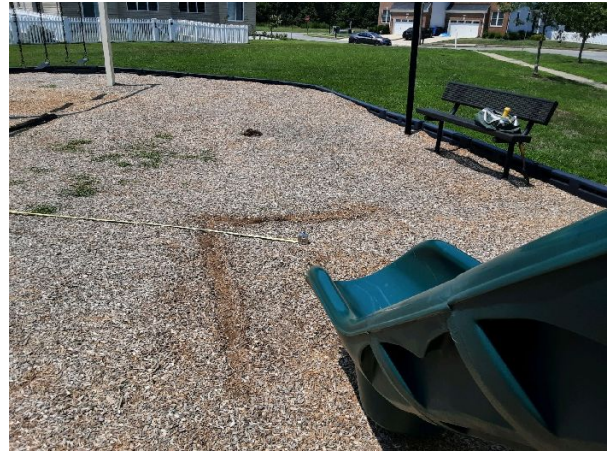
Does equipment have proper use zones?

Priority: Medium

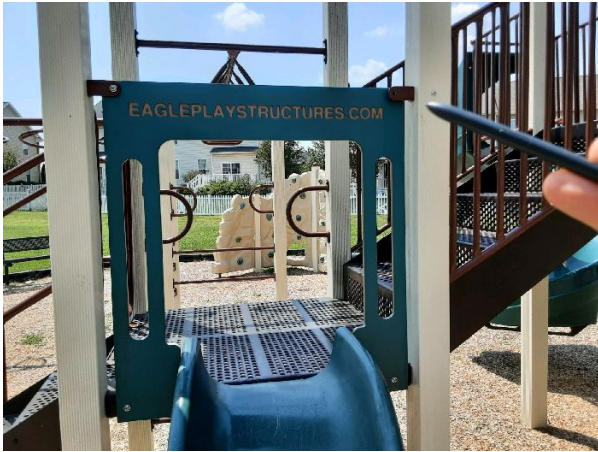
- As noted above, the sit down barrier for the right turn slide is not secure.

Priority: Medium

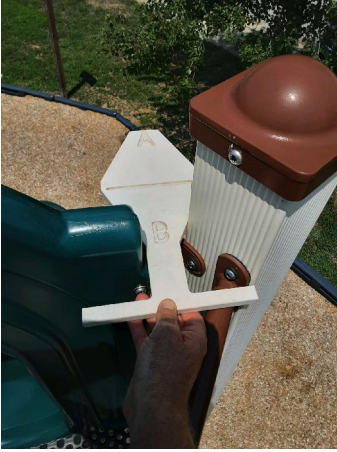
Do slides < 48" high have max. 11" height at exit; slides > 48" have exit height between 7-15"; and all slide exits are rounded or curved

Priority: Low

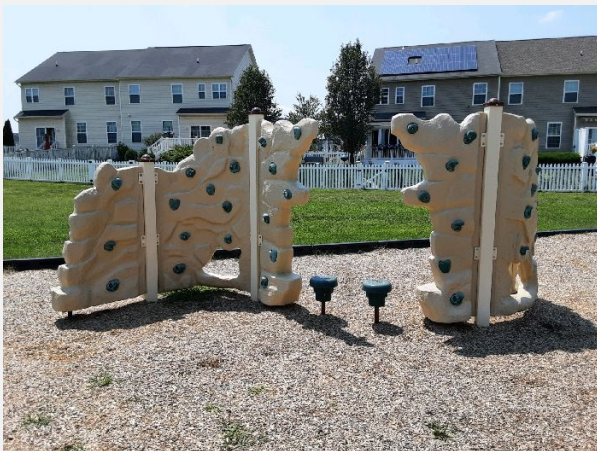
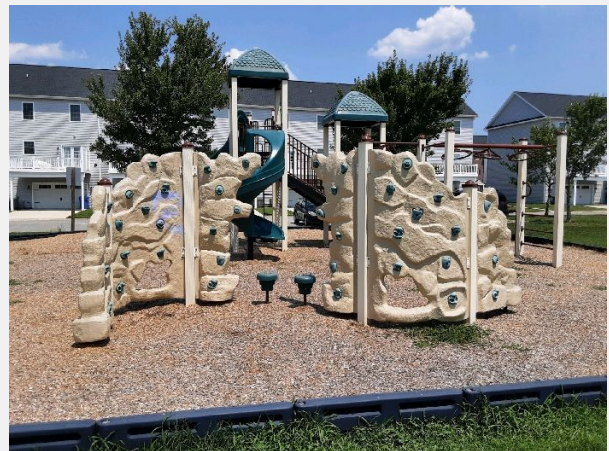
• A few of the hand grips fail the protrusion hazard test thus also making them entanglement hazards - Non-compliant grips.

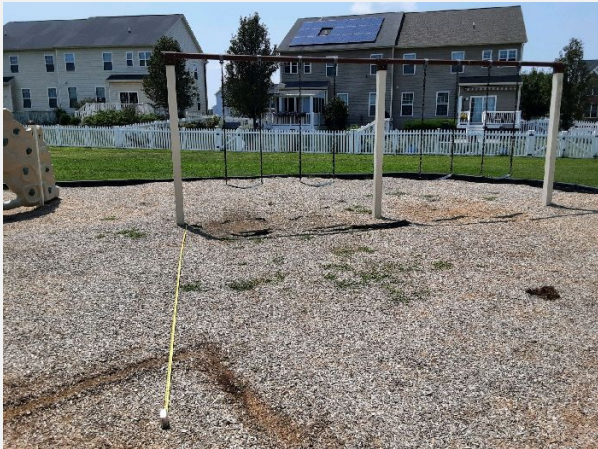
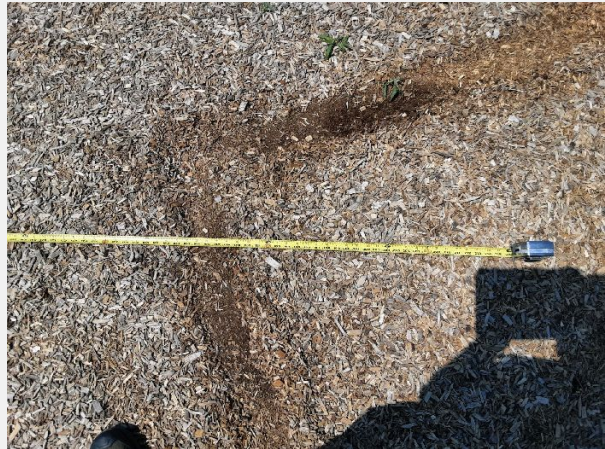
- The to-fro use zone of the belt seats is overlapping the front of the Starglide slide, as noted above.
Note: Replacing those two seats with tot buckets would remedy this.

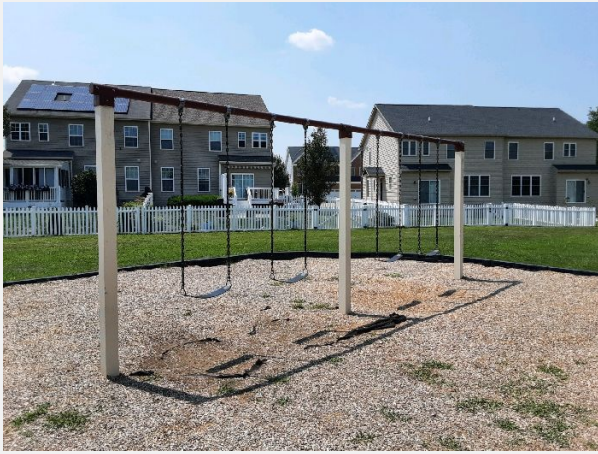
Are support footings stable and buried below the protective surfacing materials?	Yes	●
Is the swing support structure in good repair, secure with no noted movement?	Yes	●
Is equipment free of openings that can cause entrapments?	Yes	●
Are all moving components free of excessive wear?	Yes	●
Are swing seats in good condition, no cracks, splits or damage?	Yes	●
Are swing fasteners (S-hooks, lock devices, etc.) in good condition and fully closed?	Yes	●
Are swing support chains in good condition with no obvious wear or damage noted?	Yes	●
Are swing support hangers in good condition and fully closed?	Yes	●
Is equipment free of rust and chipped paint?	Yes	●
Are all components accounted for? All ends of tubing covered by caps or plugs?	Yes	●
Does protective surface area appear to be in good condition and uniform?	No	⚠
<ul style="list-style-type: none"> • Worn down to dirt & torn fabric. Fall hazard & trip hazard.

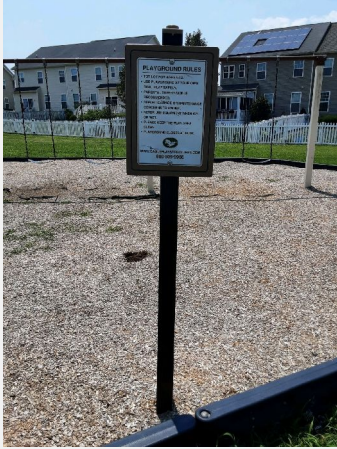
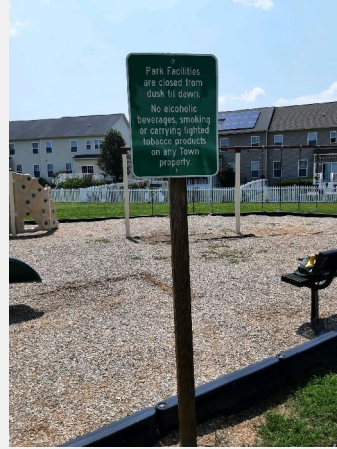
- The main age & rules sign is loose in the ground.
 - The facilities sign has bolt protrusions (impale hazards) coming thru the wood post.
- Has the fault been repaired? No Priority: Low

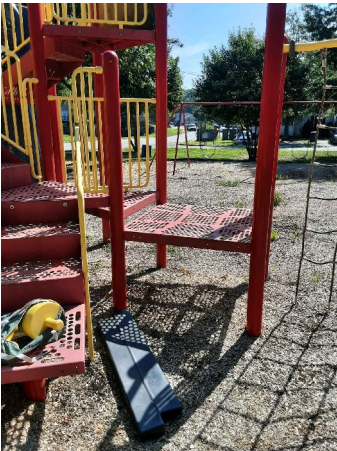
- Site #1: Transfer station elevation should be no higher than 18" - currently 21" high. Appropriate depth of surfacing would remedy this issue.
- Has the fault been repaired? No **Priority: Low**

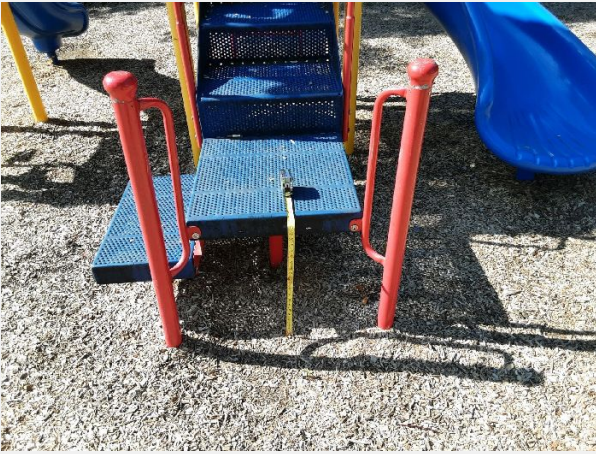
- Site #2: Transfer station is 2" too high. Adding the appropriate depth of surfacing material would remedy this issue.
- Swinging pod bridge connections are bad at the top and a rigged mess. There's old, rusty cut chain left behind also.
- Two of the three pods are loose and moving - need to be secured.

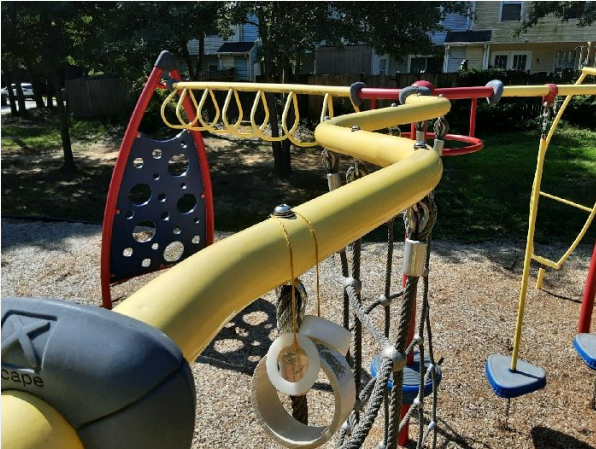
- Site #2: Entanglement hazards across the top of the rope ladder climber. Improper fasteners creating hooks / entanglements.
- Has the fault been repaired? No

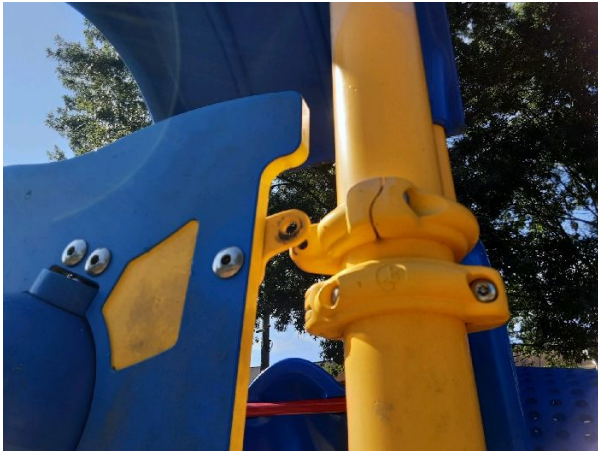
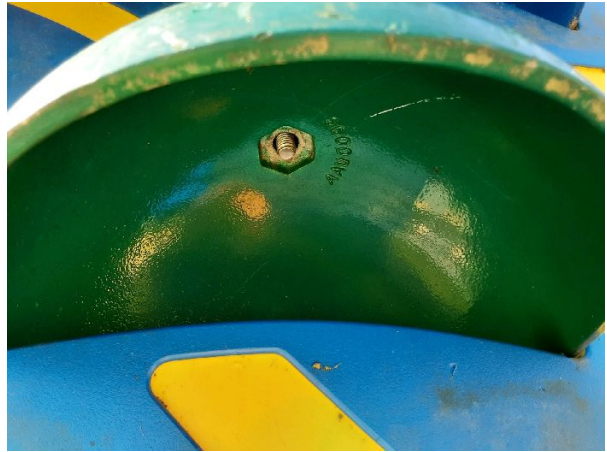
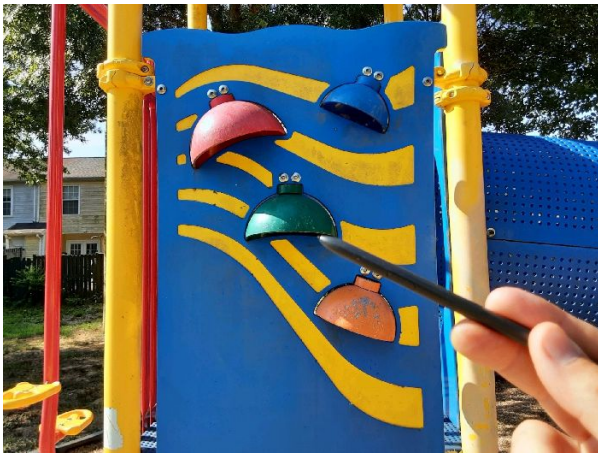
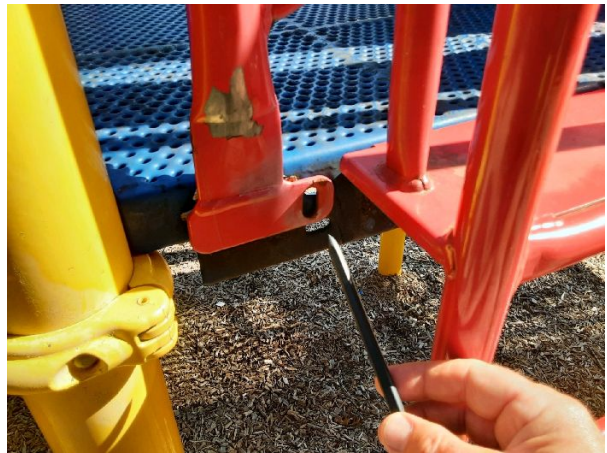
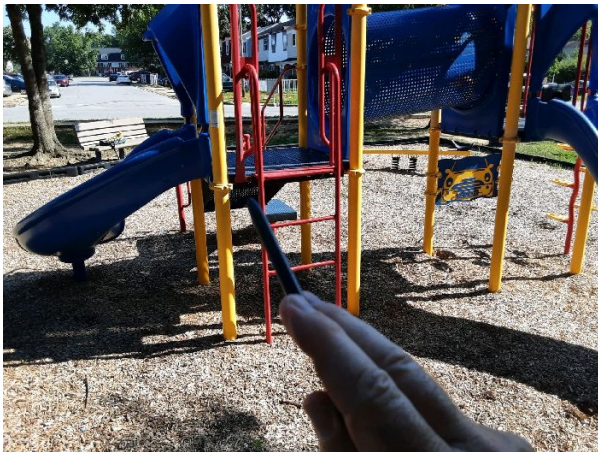
- Site #1: Fastener set missing on:
 - Tune panel has two (at the upright and on a bell)
 - Ladder climb

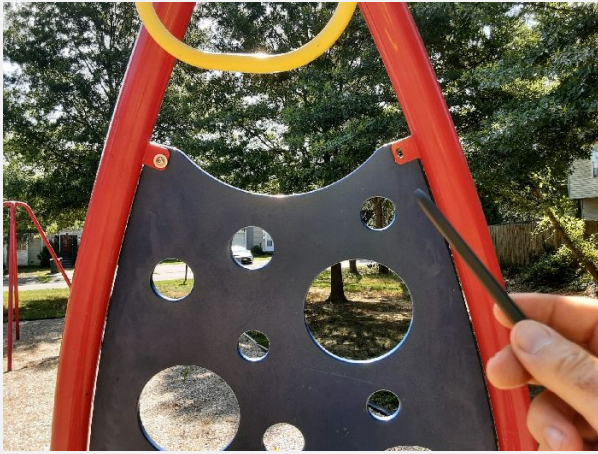
• Site #2: Plastic climbing piece at the end of the loop ladder is missing a fastener set.

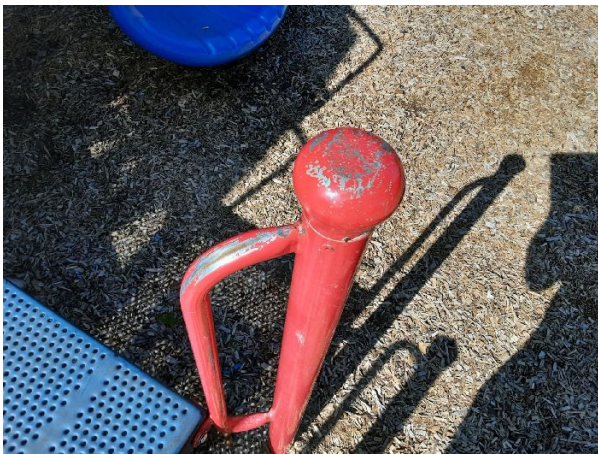
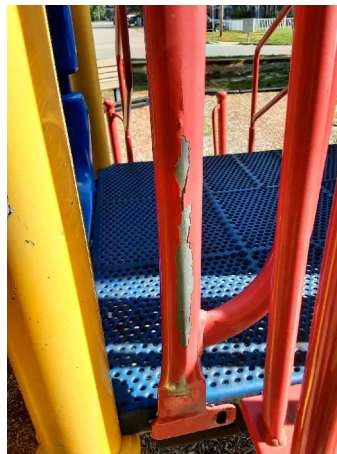
• Both structures have nicked paint and rust - mostly typical wear & tear.

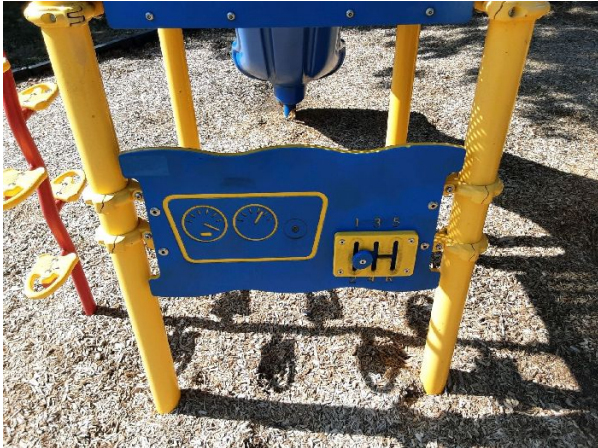
- Site #2: The steering wheel is missing on the driver panel.

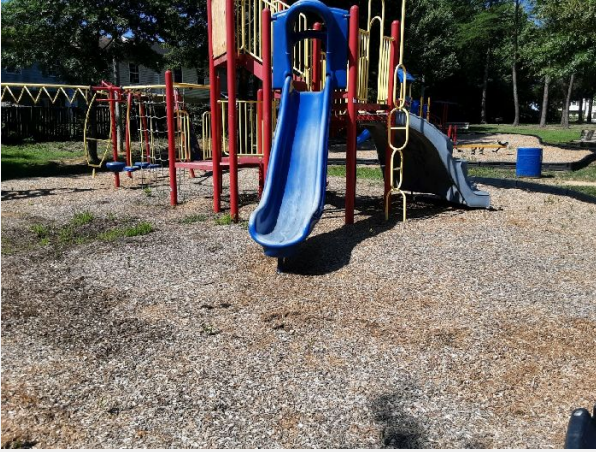
Does equipment have proper use zones?	Yes	●
Are support footings stable and buried below the protective surfacing materials?	Yes	●
Are top portions of slide including protective barriers, support bars and other related devices fully secured with no noted movement?	Yes	●
Is the slide support structure in good repair and secure with no noted movement?	Yes	●
Are access devices to slides (ladders, stairs, etc.) in good condition and secure with no movement noted?	NA	
Are all areas free of gaps between portions of slide including slide portions, platforms and other related areas?	Yes	●
Is equipment free of openings that can cause entrapments?	Yes	●
Do slides < 48" high have max. 11" height at exit; slides > 48" have exit height between 7-15"; and all slide exits are rounded or curved	No	⚠
<ul style="list-style-type: none"> • Structure #1: Both slides are an inch or too high at the exit - appropriate depth of surfacing would remedy this. • Structure #2: Wave slide is an inch too high at the exit - appropriate depth of surfacing would remedy.

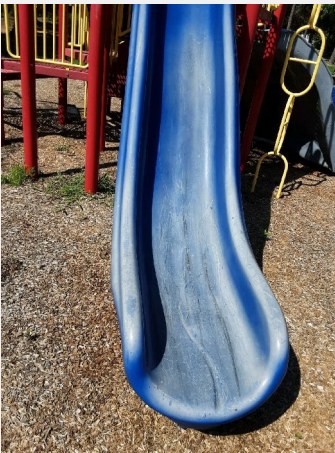
• Structure #2: The UV stabilization and plastic is worn & faded here although slide seems to be in good condition otherwise.

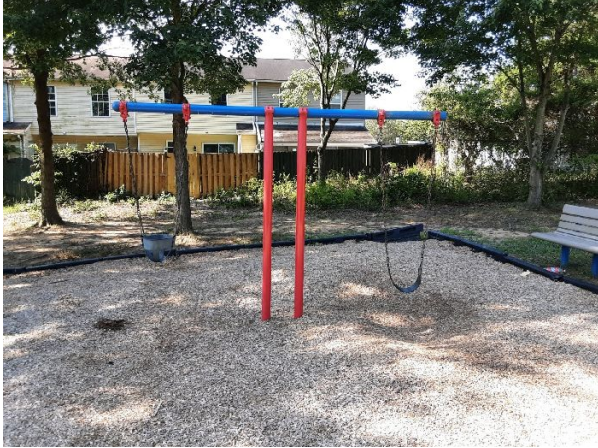
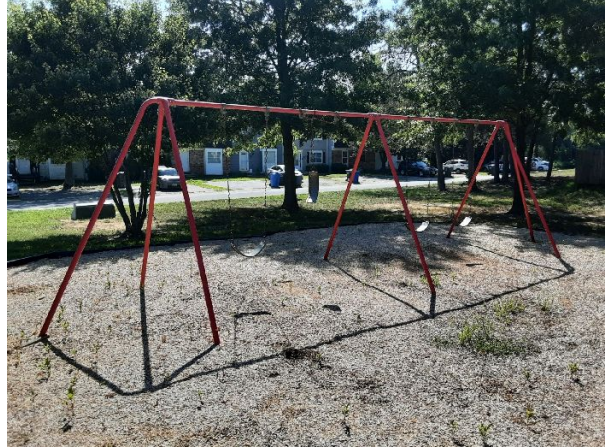
Pictures of Swing Sets	Notes
<ul style="list-style-type: none"> • Site #1: T-swing with a belt seat & a tot bucket.

- Site #2: Double bay a-frame swing set w/ four (4) belt seats.

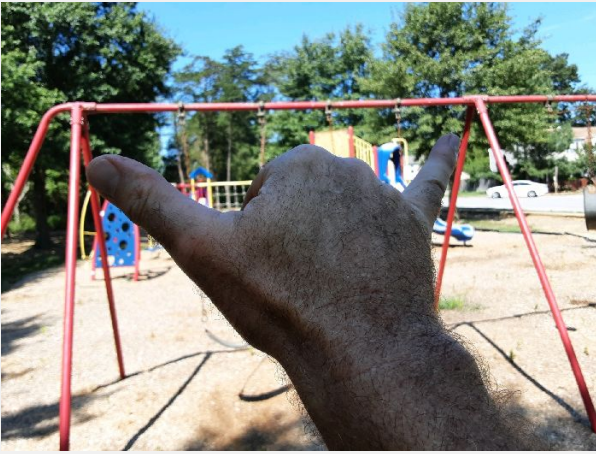
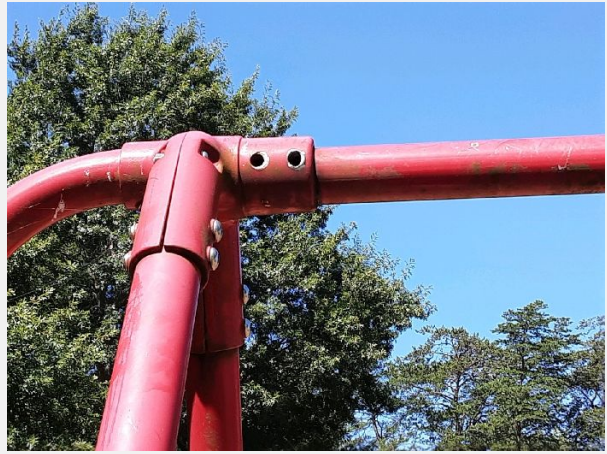
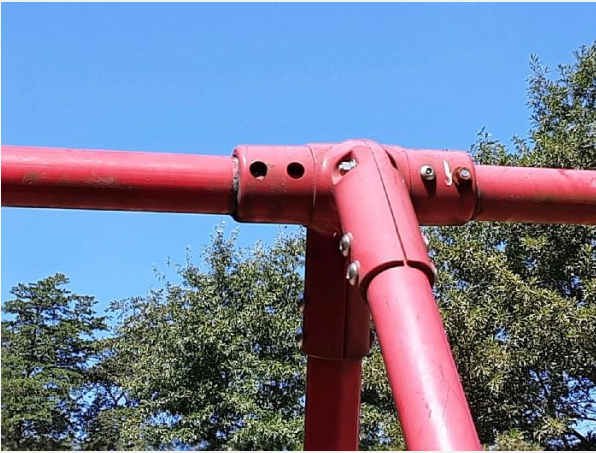
- Site #2: Two of the four collars are missing through-bolts so the top beam moves when in use & thus is not "secure".

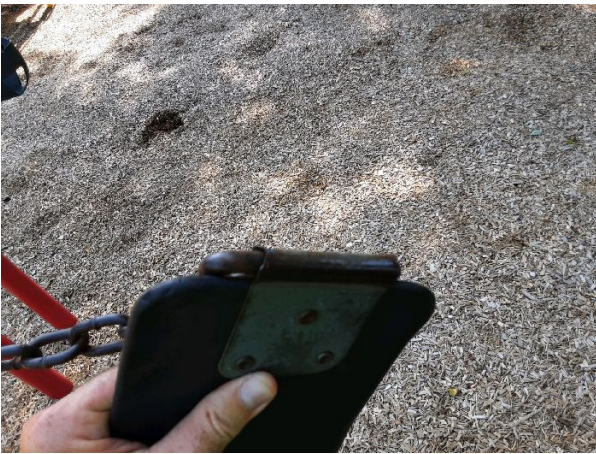
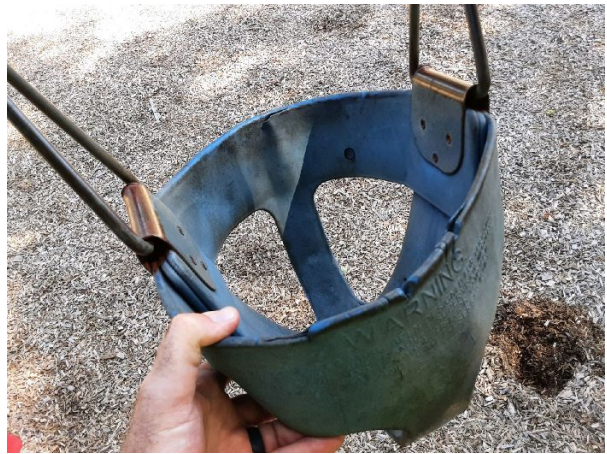
• Structure #1: Both the tot seat & the belt seat are damaged. The tot seat is the worst. The entire frame has failed and the bracket is bad on the belt seat.

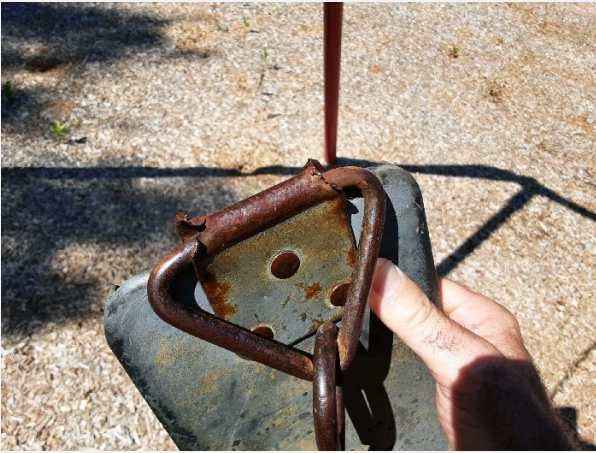
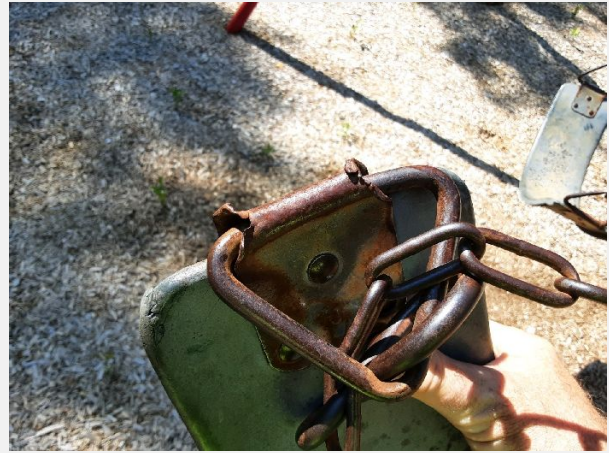
• Site #2: All four (4) swing seat brackets are very worn, sharp & breaking.

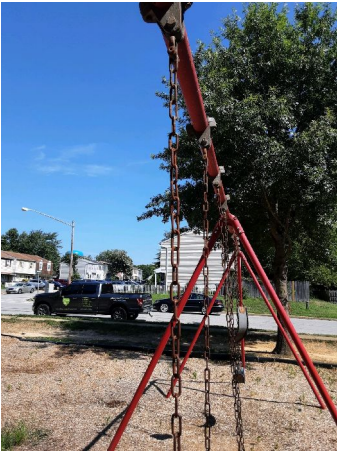
• Site #2: All eight swing chains are showing rust & wear. Need replacement.

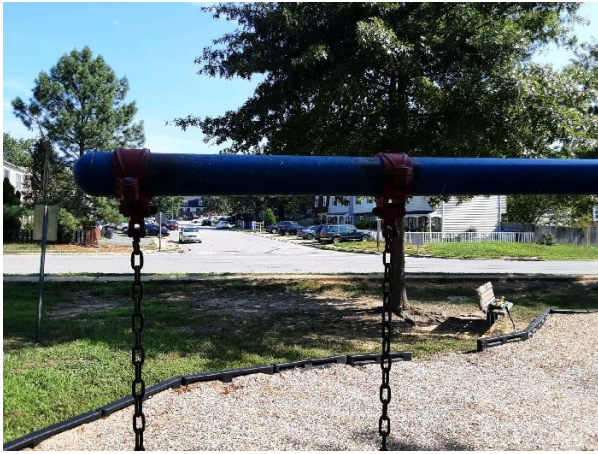
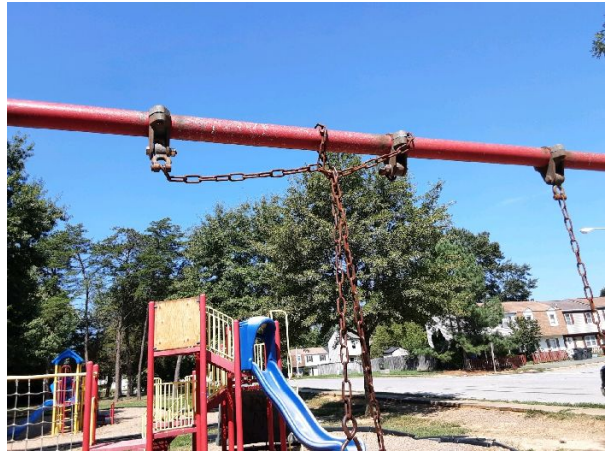
• Chipped paint & rust throughout.

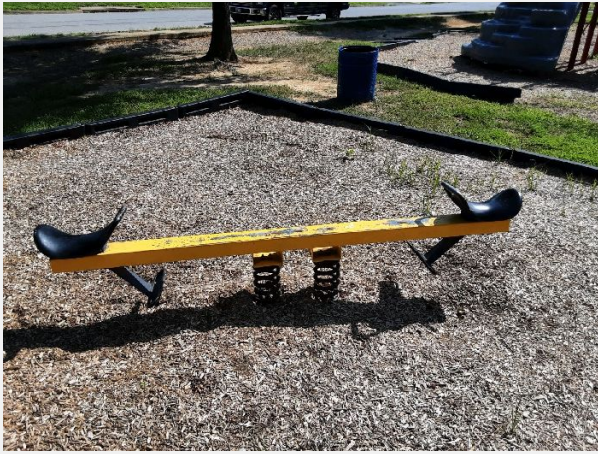
Does equipment have proper use zones?	Yes	
Are support footings stable and buried below the protective surfacing materials? Is the Spring Toy secure, in good condition, with no noted movement?	No	
<ul style="list-style-type: none"> This spring rider is quite worn. Not sure if it's loose fasteners at the footing or just wear & tear on the springs but it has a lot of extra movement. More so than just springing up and down - no longer functions as intended. Have it evaluated by mfr. rep, serviced and / or replaced. 		
Has the fault been repaired? No		Priority: Low
Are all moving components free of excessive wear?	No	
<ul style="list-style-type: none"> Bouncer moves side to side as much or more than it moves up and down. 		
Has the fault been repaired? No		Priority: Low
Are nuts and bolts tight with no wear noted?	No	
<ul style="list-style-type: none"> Fasteners are loose where the springs mount to the footings.

Has the fault been repaired? No		Priority: Low
Is equipment free of protrusions (exposed bolts, screws, nuts)?	Yes	
Is equipment free of openings that can cause entrapments?	Yes	
Are footholds and handholds in good condition with no apparent damage noted?	Yes	
Is equipment free of rust and chipped paint?	No	
<ul style="list-style-type: none"> Paint worn away down to bare metal in some places. 		
Has the fault been repaired? No		Priority: Low

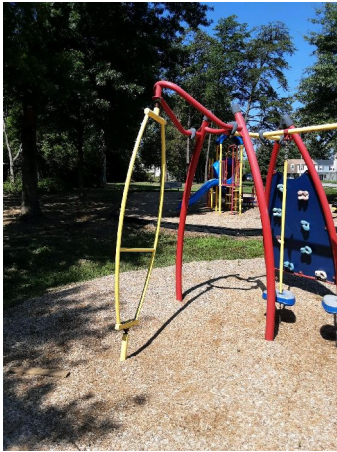
- Site #2: Stand-up spinner attached to Xscape structure. (GameTime)

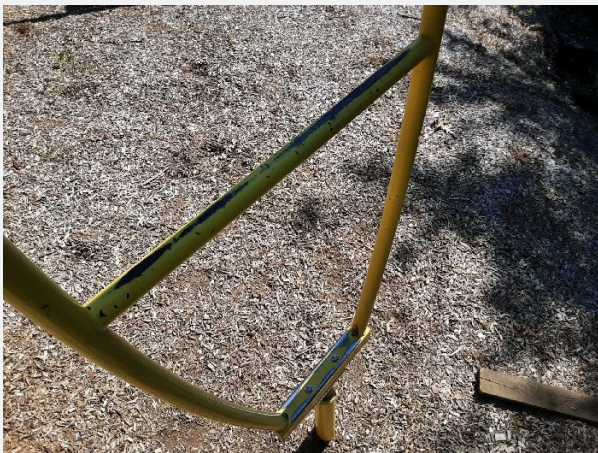
• Worn, chipped paint.

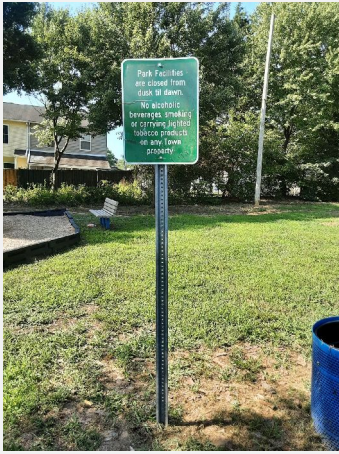
Is playground signage provided, secure and in good condition?
Adult supervision & Age appropriateness recommended?

No
