**Parks and Recreation Commission
Regular Meeting
April 8, 2026, 8:00 AM
Meets virtually via Microsoft Teams**

TOWN OF LA PLATA
Parks and Recreation Commission Minutes
January 14, 2026, 8:00 AM
Regular Meeting
Meets virtually via Microsoft Teams

Park	Address / Location	Year Built	Owner	Foundation Condition	Equipment Condition	Measurements / Square Footage (internal area)	Equipment Manufacturer	Signage	Notes
Wills Park	503 St Mary's Ave	1984	Town	Poor	Poor / Safety Issues	97 x 77 = 7,469		hrs and restrictions	Full playground upgrade FY2026. Walkway - 205 linear sq feet, future improvement need
Clarks Run	End of Silver Linden Dr	1983	Town	Fair	Good	77 x 70 = 5,390	It's a Miracle	hrs, restrictions, safety	Suggest PIP and equipment upgrade - 2029
Agricopia	Across from 1037 Crop Pl	2000	Town	Good	Very Good	72 x 48 = 3,456	Eagle	hrs, restrictions, safety	Suggest PIP and equipment upgrade - 2030; or when needed
Caroline Dr (2) - Tot Lot	End of Caroline Dr	1990	Town	Poor	Poor	54 x 30 = 1,620		hrs and restrictions	Suggest we remove and not replace. Playground now adjacent to La Plata Pkwy. If Town invests, we should only invest in large Caroline Dr park.

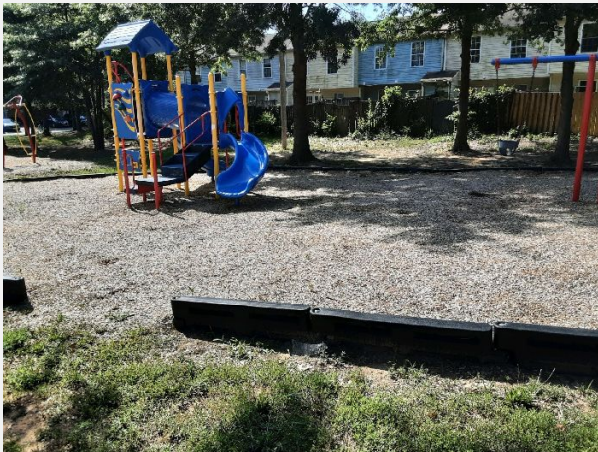
- Site #1: Measured throughout site and average depth is somewhere between 2" - 4".
- Site #2: Measured as much as 12" on the back side and as little as 2" in the front. In the middle there is 2" - 4" for the most part.
- There's significantly less than the required depth in & around the actual equipment, plus there's lots of grass and weeds and exposed fabric.

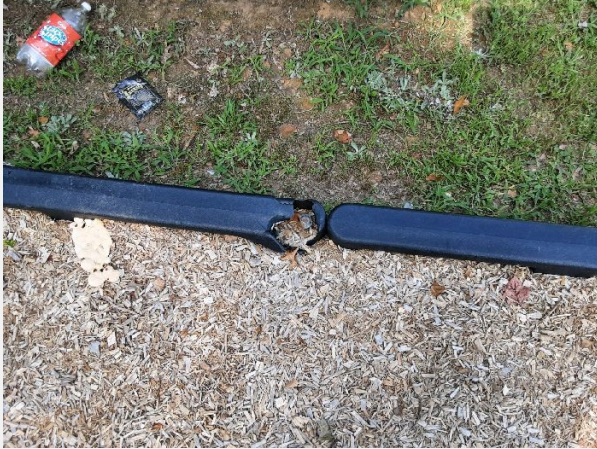
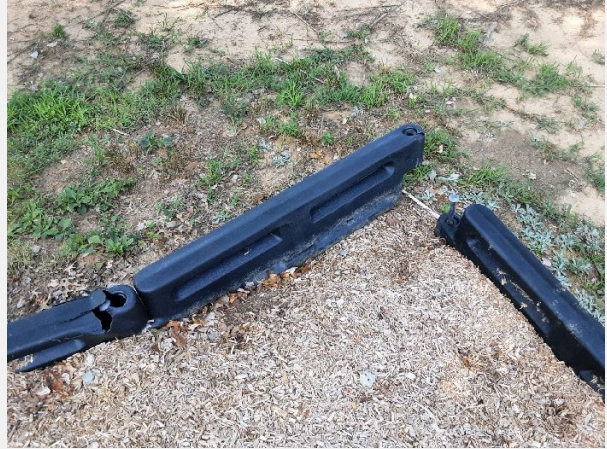
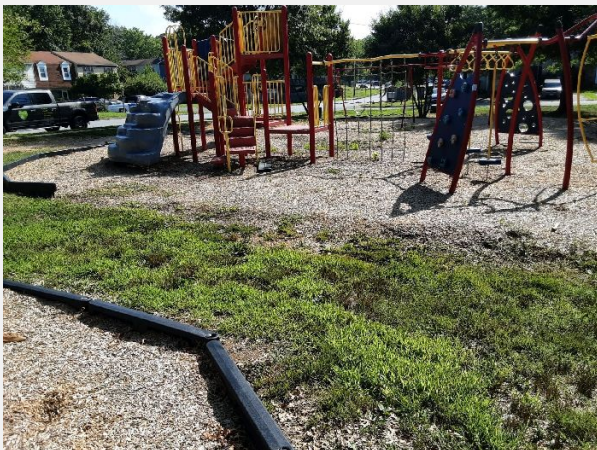
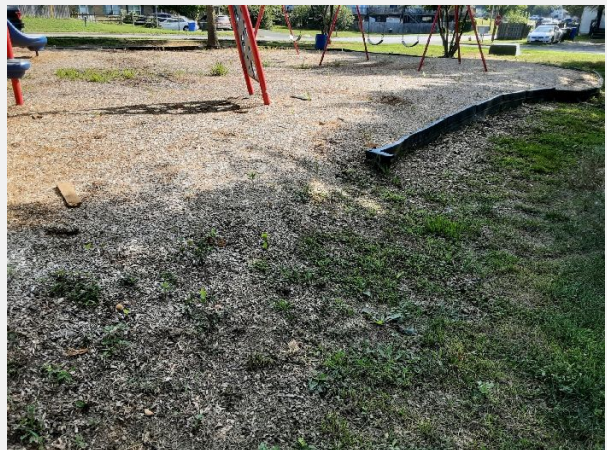
- Borders are damaged, leaning & some are just missing.

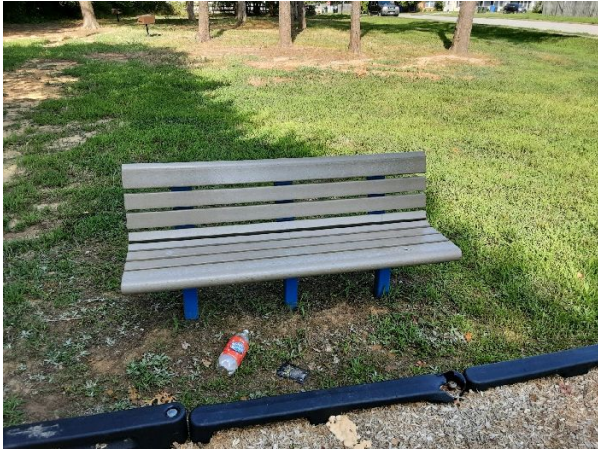
- One bench has several cracks the other ones damaged with multiple planks being broken.

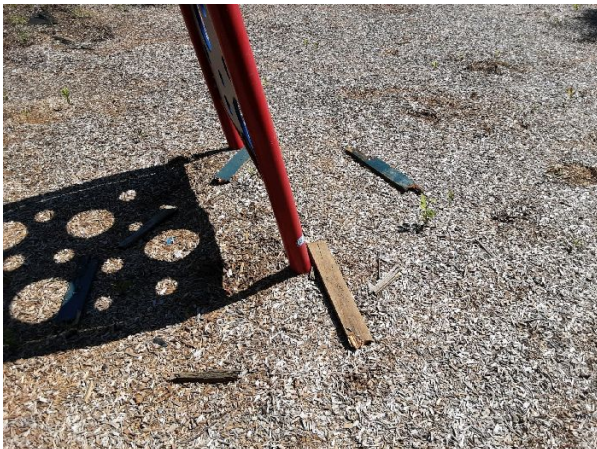
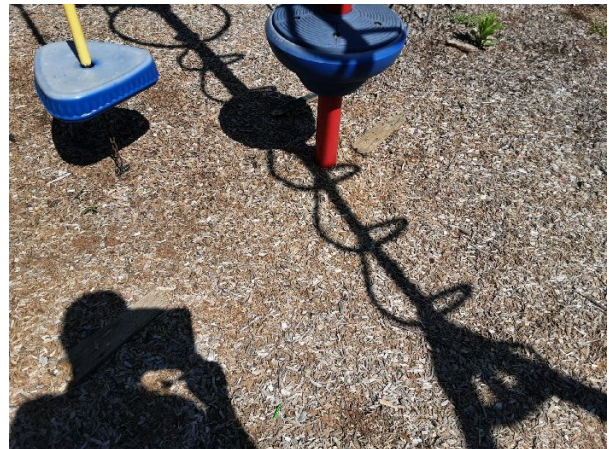
• This site has lots of trash, wrappers, cigarette lighters, drug paraphernalia around the site, broken wood boards, broken wood timbers in the site and all the trash cans stink of dog feces when you come within a few feet of of them. They're swarmed with flies today in the hot sun. There's dog feces IN the play area mulch as well.

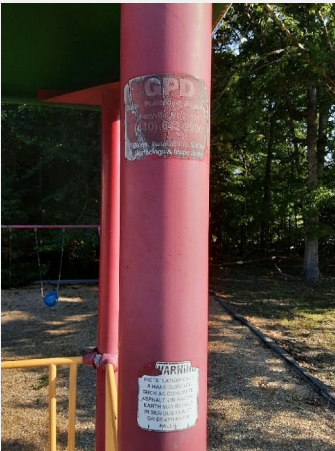
Are warning labels and age appropriate signage present and legible?

No

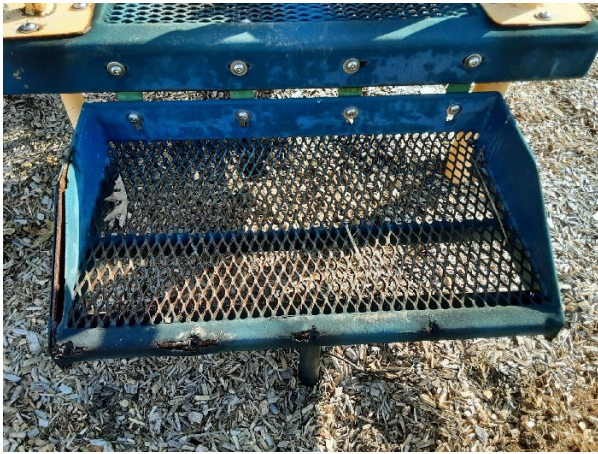
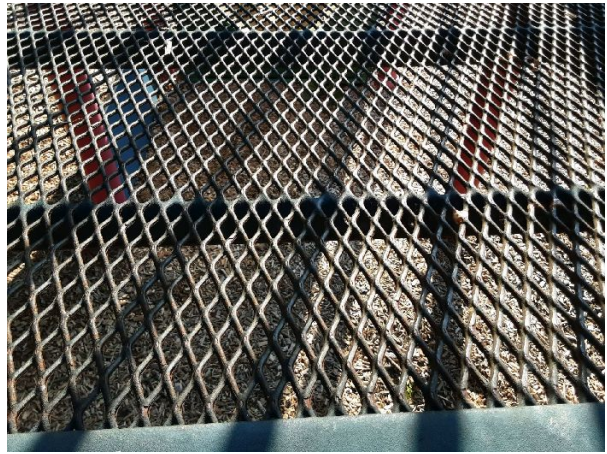
- PVC coating has failed on the decking. Coating has worn away to rusty metal exposed on the deck & on the transfer station riser.

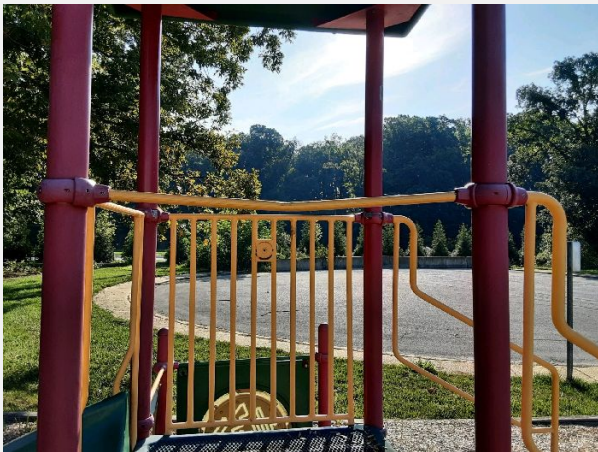
- Guard rail for the chain net climb is bent and loose.

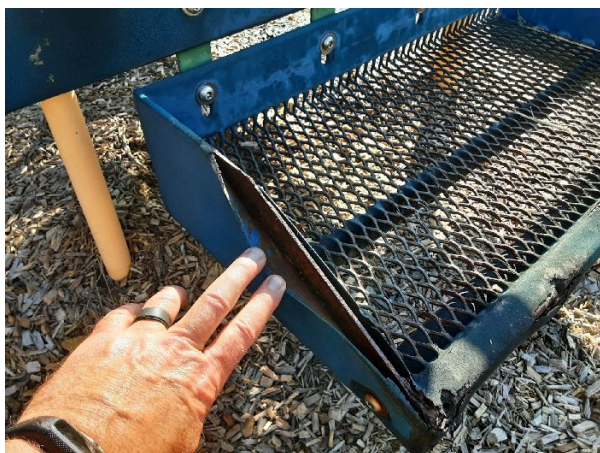
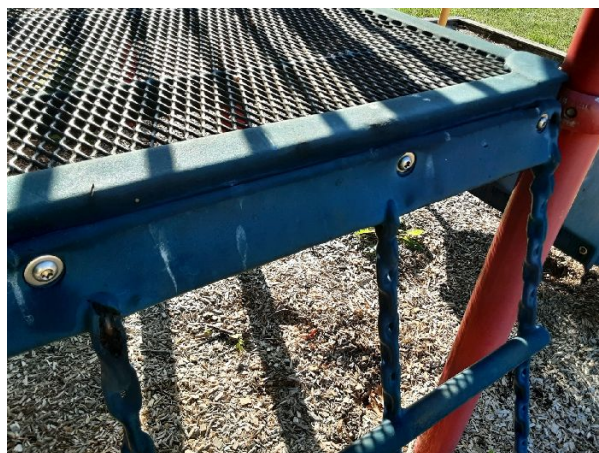
- The transfer stations riser is peeling down to the rusty metal.
- The chain net climb is deteriorated & rusting away.

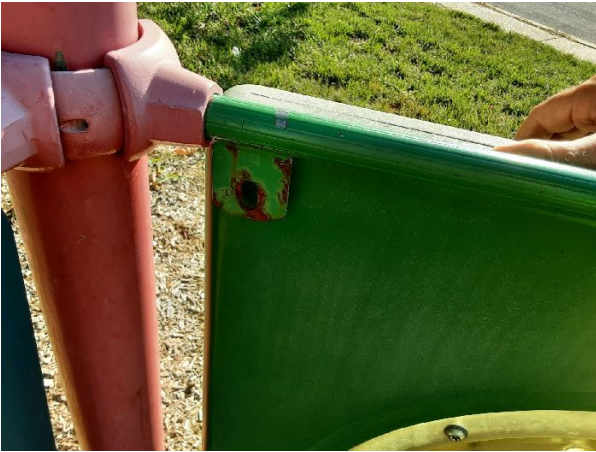
- Missing a fastener on the maze panel.

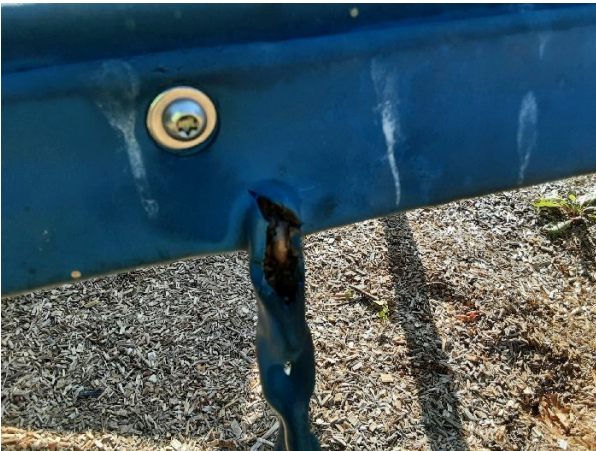
• The s-hooks connecting the chain climb are degraded as is the plate that mounts to the deck. Failing.

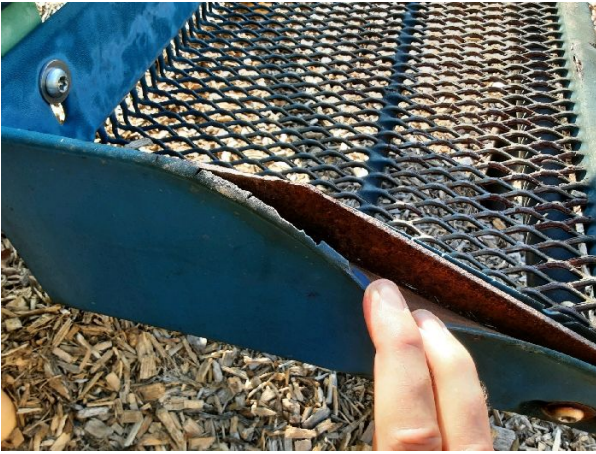
• Sharp edge on the corner of the transfer station riser where the PVC coating is worn away and we have rusty, exposed metal.

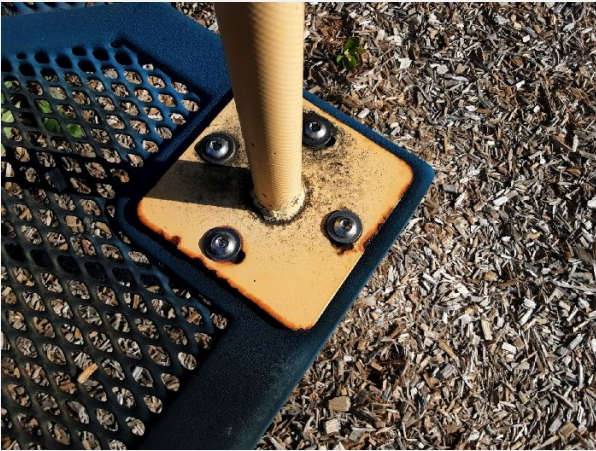
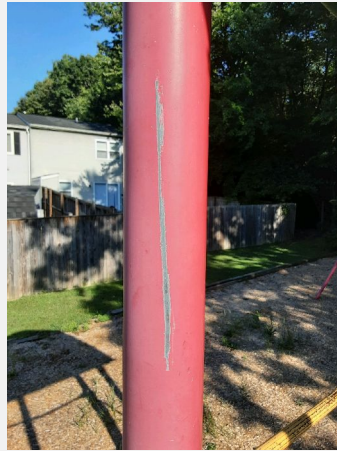
• Wherever decking is exposed, which is predominant, there's rust & there's also chipped paint on most painted metals.

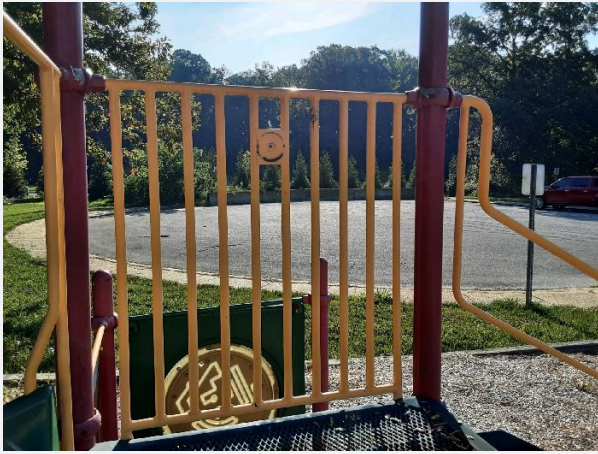
• Pipe rail panel missing its driver wheel.

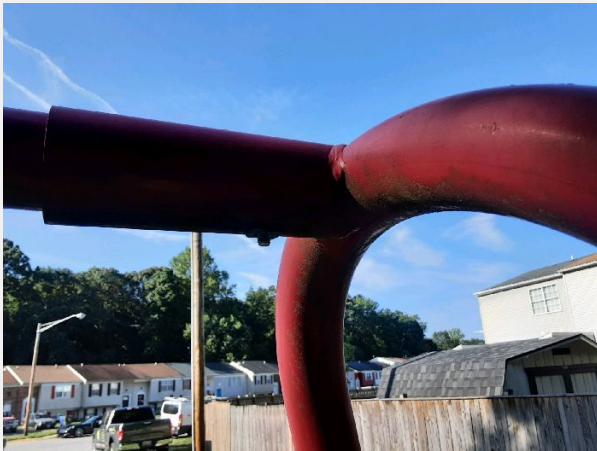
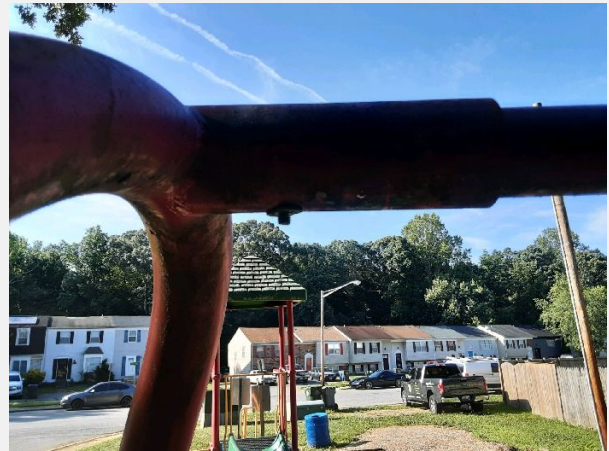
- The swing support structure has protrusion hazards on both sides in the form of set pins or bolt ends that are protruding beneath the collars.

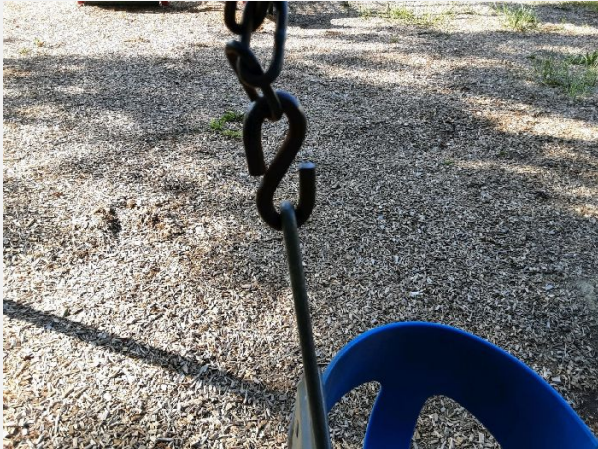
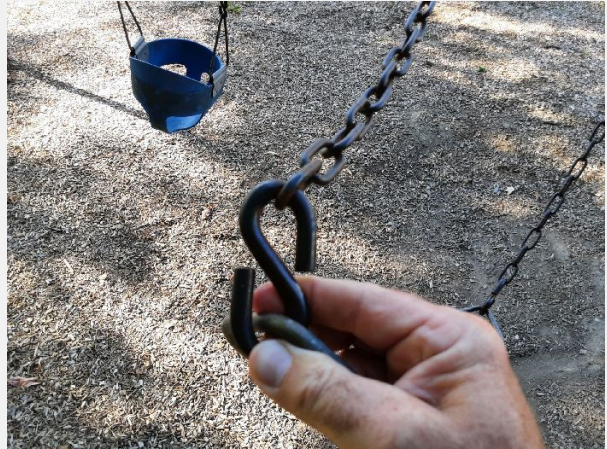
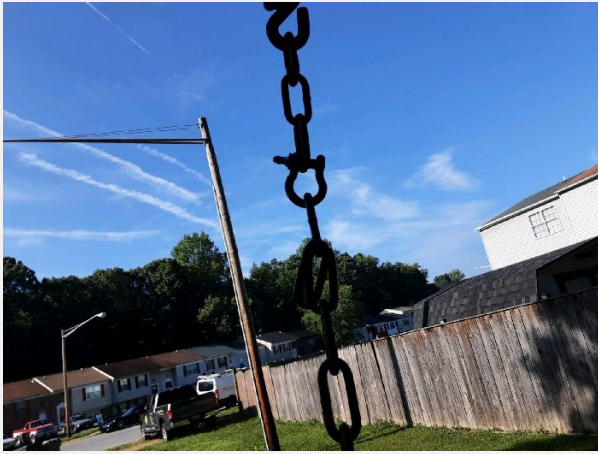
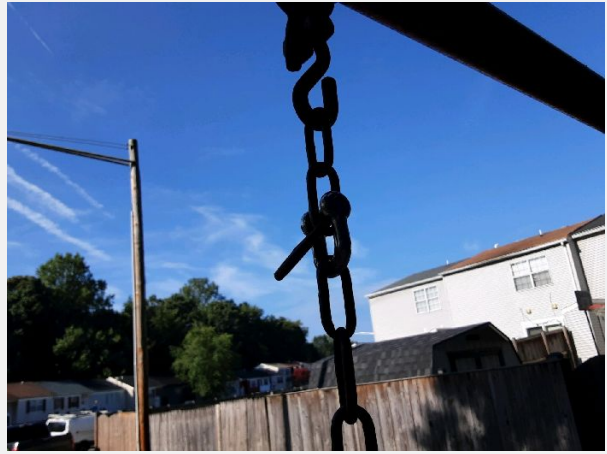
- Eight (8) s-hooks present, (7) of which are non-compliant plus the addition of some clevises or shackles added to link chain sections which is not permitted and just rigging bad chain. Instead, replace the chain.

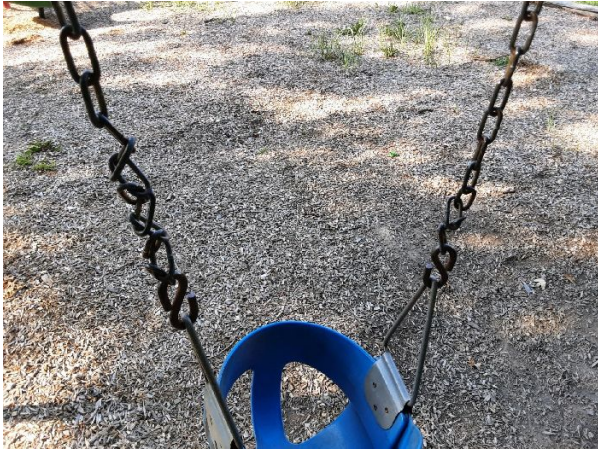
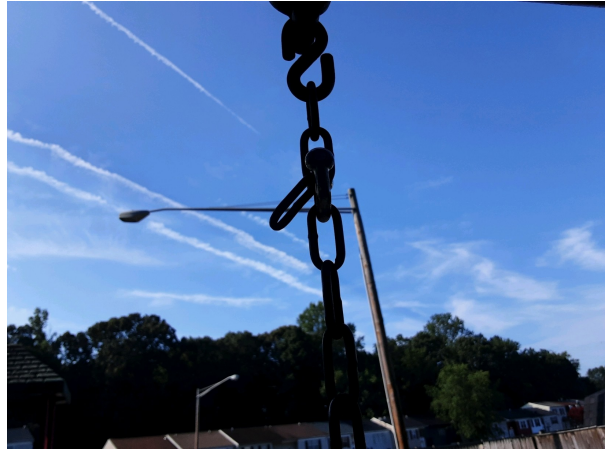
• Chains are rusty, kinked and there's excess links with some chain being pieced together with non-compliant shackles.

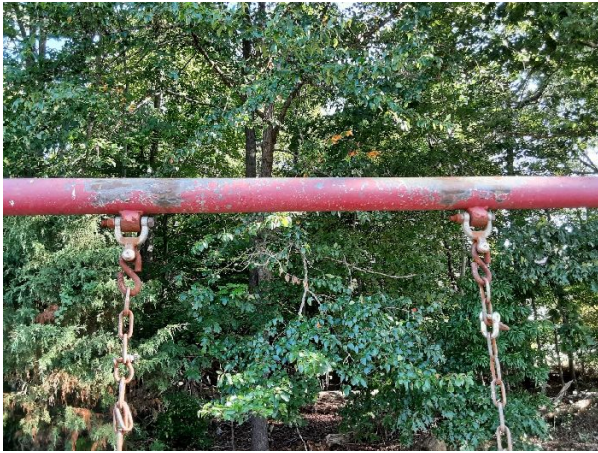
- Rust present where there's chipped paint and on the top beam, hangers, the hardware and the chain.

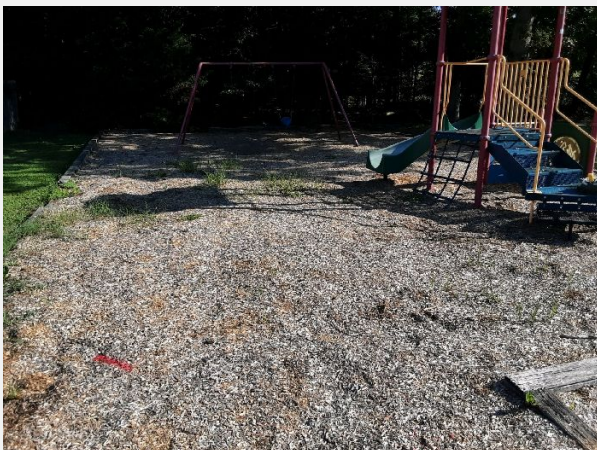
- Measured throughout today to find mostly 9" around the play structure. As you go back towards the swings we get as low as 0 - 3" depth.

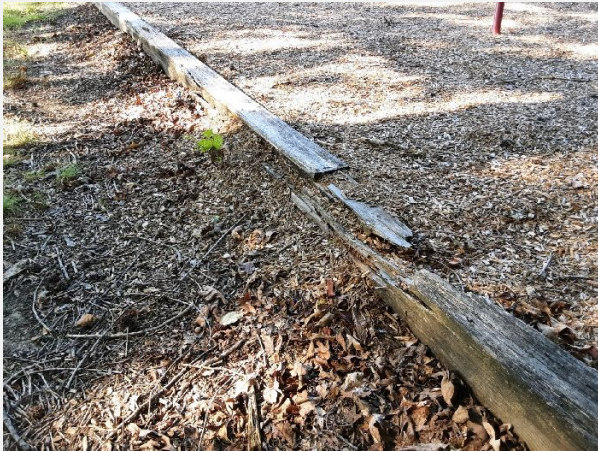
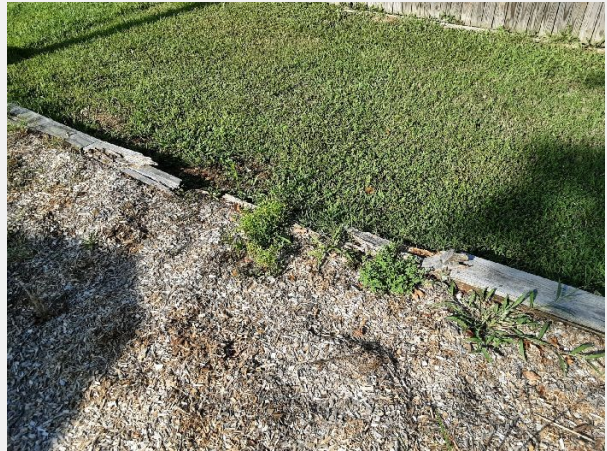
- The wood borders are rotting, deteriorated and damaged throughout the site.
- There's some wood sticking up like spikes or splinters & a large rebar spike near the entrance - implement hazard.

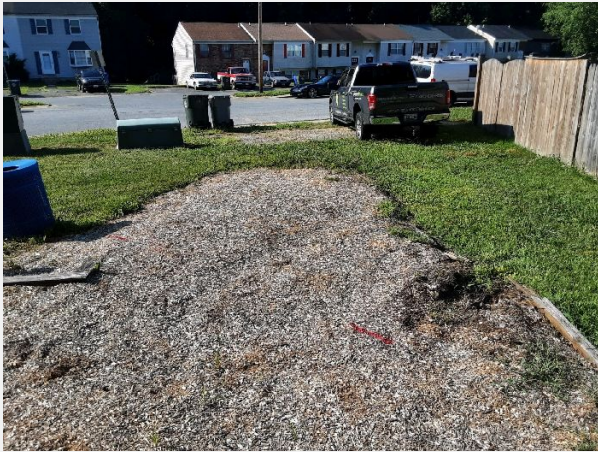
- Looks like extra wood chip material just generally dumped unevenly in front of the play area where there's an opening and damaged borders with uneven grass between it and the concrete ramp up at the street.
